## QUINQUENNIAL INSPECTION REPORT

**CHURCH OF ST. LAWRENCE  
LECHLADE-ON-THAMES**  
*In the Diocese of Gloucester*

September 2021

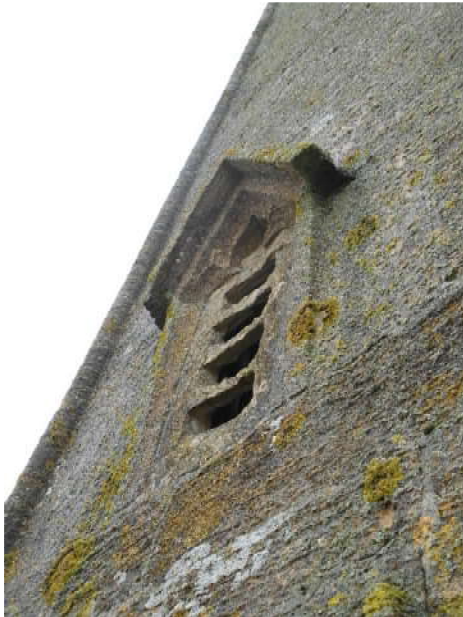
Example of weathering to spire lucarne louvres

- 3.02 In addition, to the steeplejack's assessment, the following additional points were noted in terms of the spire masonry:
- Varying degrees of weathering/erosion to the stone louvres contained within the lucarnes, as well as to the decorative hoods over. Whilst this does not give immediate cause for concern, it is recommended that they be visually monitored during the next quinquennial cycle – and consideration made to taking a photographic visual record on an annual basis to allow the rate of decay/loss to be monitored so that future repairs (if necessary) can be appropriately planned in advance. **O**

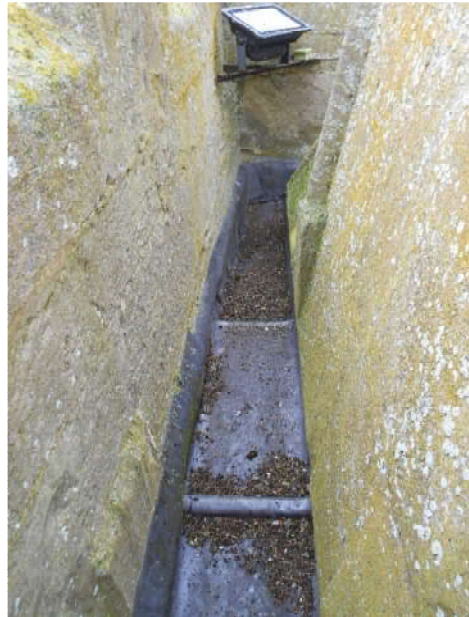
Debris build up to tower parapet gutter

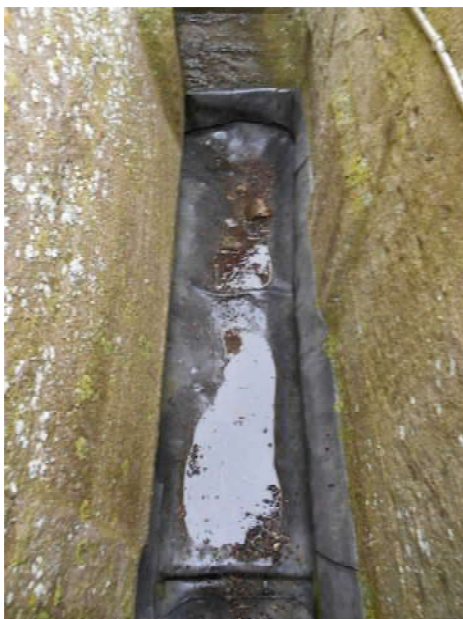
- 3.03 As noted in the previous QI report, the lead-lined parapet gutter is 'irregular in places' with water pooling. This was especially evident as the latest inspection followed a rain shower – it would appear there are failings to the substrate below the lead sheets allowing the water to pool. Furthermore, there was a build-up of debris in some areas of the gutter. These areas should continue to be visually monitored and their routine clearance should continue to form part of the cyclical maintenance regime – it is also recommended that consideration be given to the renewal of the leadwork, these works will also likely include upgrading/improvement of the substrate to reduce the risk of water pooling in the future. A section of cover flashing was also missing from the parapet gutter which should be replaced in the next quinquennial cycle (as it is in a sheltered position). **O/M**

Water pooling to uneven bays to tower parapet gutter

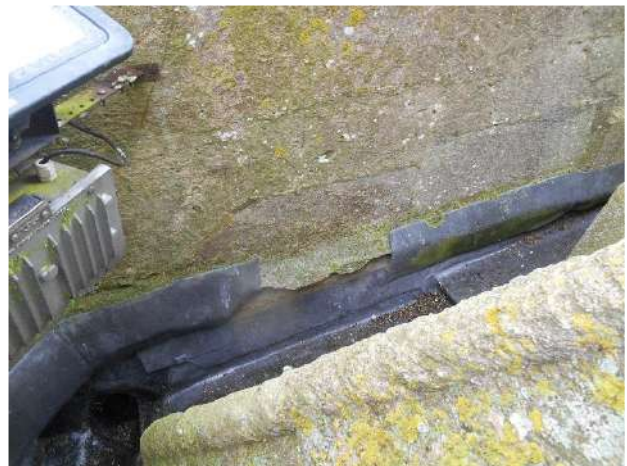
Section of missing cover flashing to tower parapet gutter

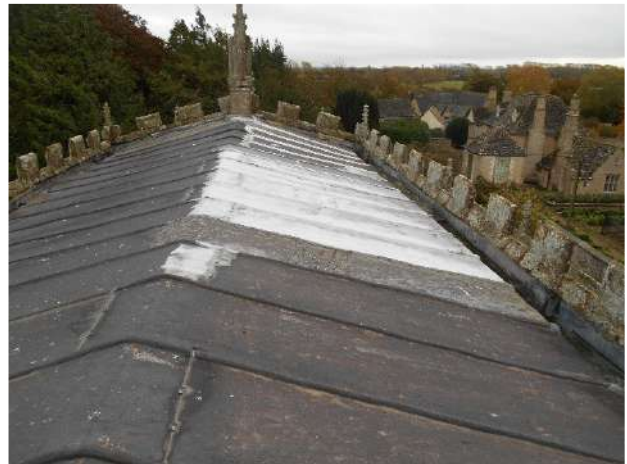
- 3.04 The eastern half of the southern slope has been painted with a paint/sealant to 'temporarily' address previous leaks/issues with the leadwork. This finish has been applied to some of the lead bays complete, with the remainder being only to rolls and across laps (the latter is not ideal if it restricts expected thermal movement – so this should be visually monitored, for splits/failures, during the next quinquennial cycle). This is only a short to medium-term solution and consideration should be given to the wholesale replacement of these failing lead finishes in the medium to long-term. **O**

'Temporary' solution painted across east end of south slope of nave

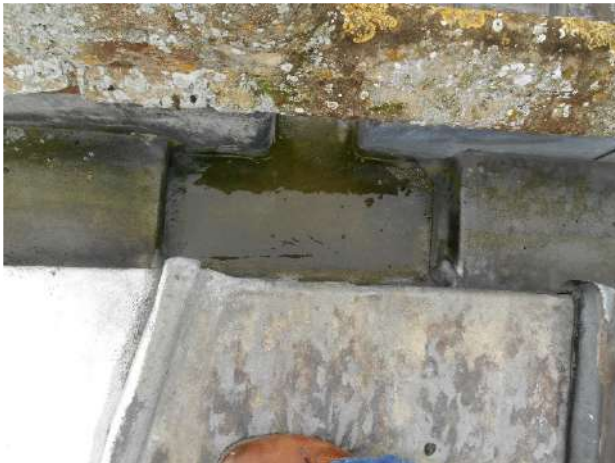
Rainwater build-up and some debris (minor) to nave parapet gutter catchpit (south side)

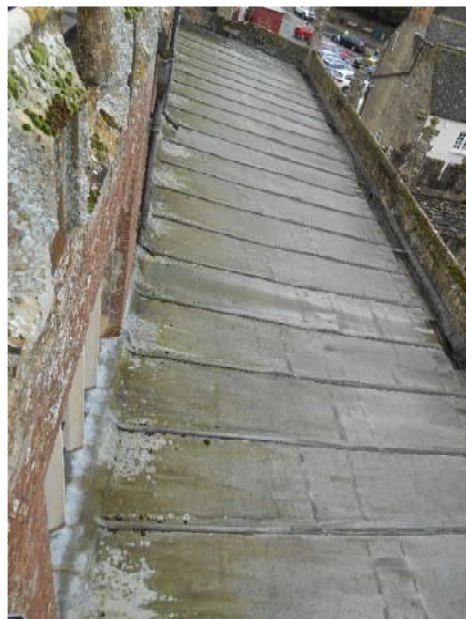
- 3.07 There appeared to be signs of previous repairs (presume splits) to some of the rolls – and as would be expected in this location, there is algal staining towards the heads of the sheets near where they abut the clerestory walls (as they are out of direct sunlight). Care should be taken when walking over these areas as it can increase the slippiness and consideration could be given to carefully brushing this off if the build-up worsens. **M**

View across north aisle roof (from nave) looking west, with algal staining and some debris evident to head of sheets – as well as shadowing of sarking boards below

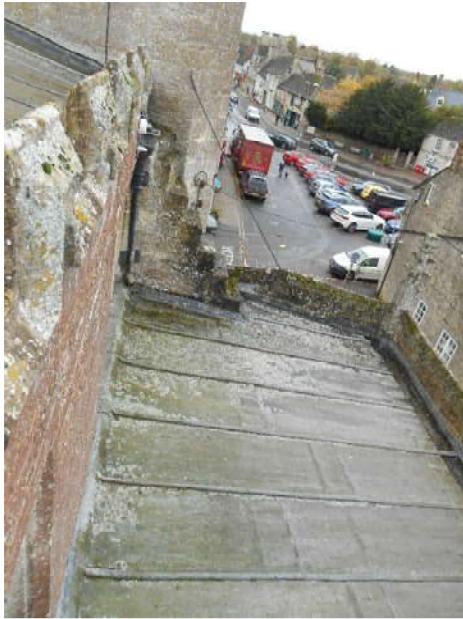
Stone steps from nave roof to north aisle (west) roof – open sided with single handrail only and no other safe safety measures over sheer drop

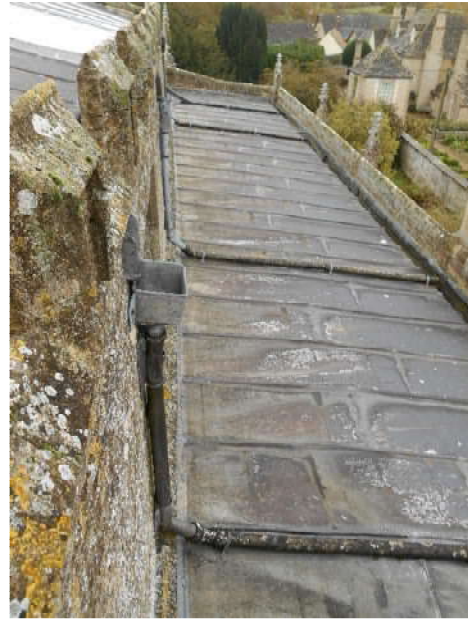
- 3.12 Compared to the nave and north aisle roof slopes, the evidence of the shadowing from the sarking boards supporting the sheets below is far more noticeable to this slope including additional staining to these areas suggesting water is readily held in these areas as well as the sheet lap locations. Furthermore, there appeared to be some unevenness across the fall of the roof towards the west end of the slope. As noted in the previous report, consideration should be given to the renewal of the lead-sheets (and likely some of the sarking board substrate) in the medium-term – whilst in the short-term this slope should also be visually monitored for worsening of the pooling of water or splitting of the sheets across these areas. D  
O

View across south aisle roof (from nave) looking east, with asbestos pipework transferring rainwater over roof and shadowing of sarking boards below clearly evident

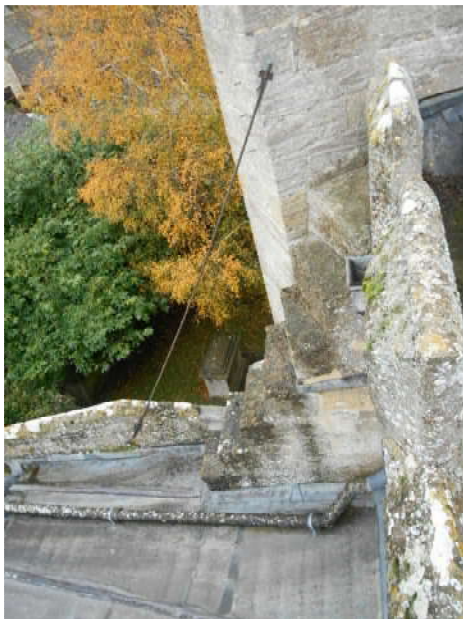
Stone steps from nave roof to south aisle (west) roof – open sided with single handrail only and no other safe safety measures over sheer drop

- 3.14 As noted with the north aisle situation, given the risks associated with the current 'limited' access between the nave and south aisle roof slope, consideration should be given to improving the safety of the existing stone access steps – this could include improvements/additions to the existing handrail arrangement in terms of simple but practical balustrading to address the sheer drop and possibly the addition of a fall-arrest cable (though this will require detailed consideration in terms of the aesthetics and its impact upon the character of this grade I listed building, especially given its unhindered visual appearance to the principal west elevation). Furthermore, consideration could be given to the addition of non-slip metal treads fitted over the stone treads, to reduce the risk of slipping when moving across this area. D

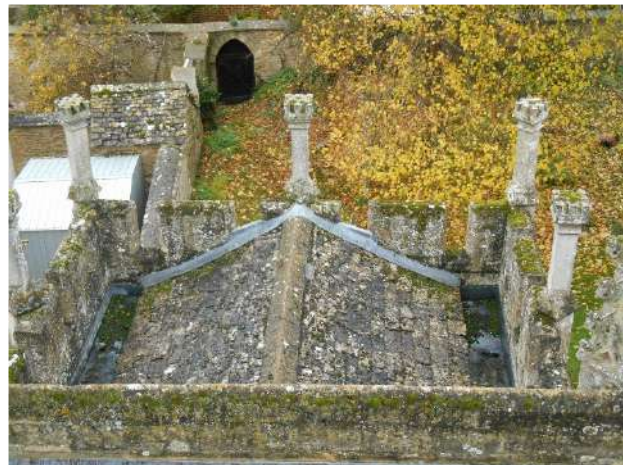
- 3.15 From the limited views, the condition of the stone tiles and ridge appeared reasonable. However, there was various areas of moss build up across their surface, which over time will retain moisture on the stone surface so increasing the risk of failure/spalling to the stone. When safe access permits, consideration should be given to the careful removal of the moss with either a soft brush or wooden spatula. C

View across north porch roof from nave roof, moss growth to stone tile roof and debris build-up to both parapet gutters.

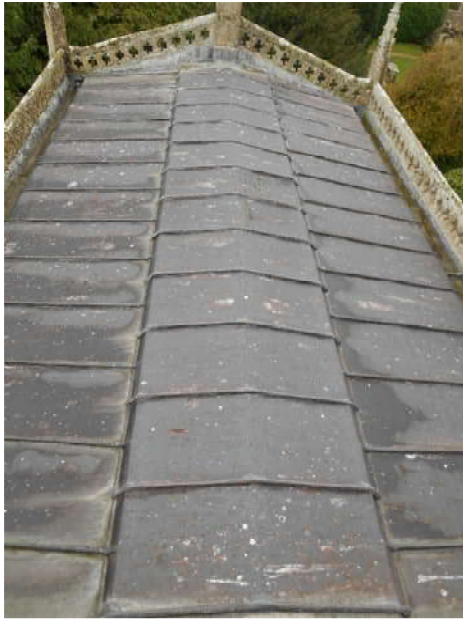
- 3.19 Again, as with the upper parapets, there was some localised areas of debris build-up to the parapet gutters – and staining indicative of water pooling in areas. These should continue to be visually monitored and their routine clearance should continue to form part of the cyclical maintenance regime. O/M

View across chance roof, with stepped ridge, looking east from nave roof. Debris build-up to both parapet gutters

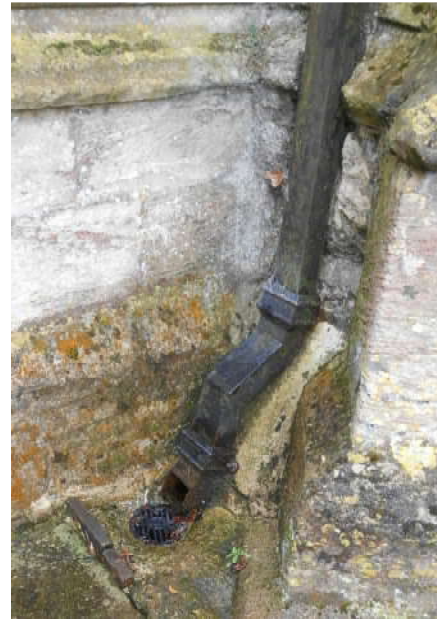
- 3.22 The downpipe from the north west corner of the north aisle, which also has a connection from the Vestry roof below appeared to be in reasonable order – for the record, it is understood that anti-climb paint has been applied to this downpipe, in addition to the spiked array fitted near the Vestry parapet to help deter vandal/theft access with regard the vestry roof covering. There was some staining and surface corrosion to the base of this downpipe – it is recommended that this be treated and redecorated. **C**

Staining and surface corrosion to base of North Aisle/Vestry downpipe

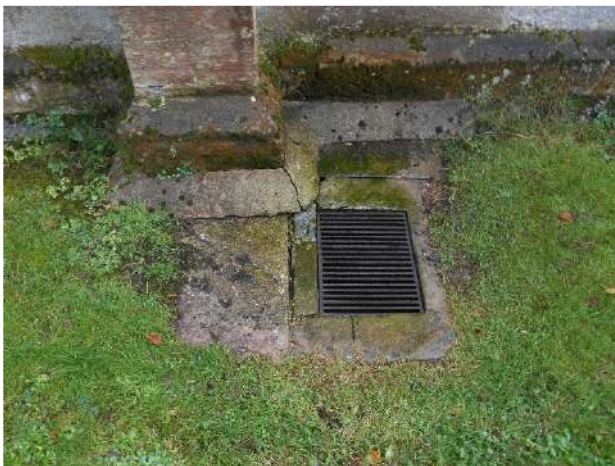
- 3.24 The concrete aprons around some of the grate covers has opened up/fractured – this would benefit from being repointed to prevent vegetation becoming established and to also ensure excess surface water is directed towards the below ground drainage system whenever possible. **B**

Example of open joints/cracking to aprons and flaunching's around drainage grates

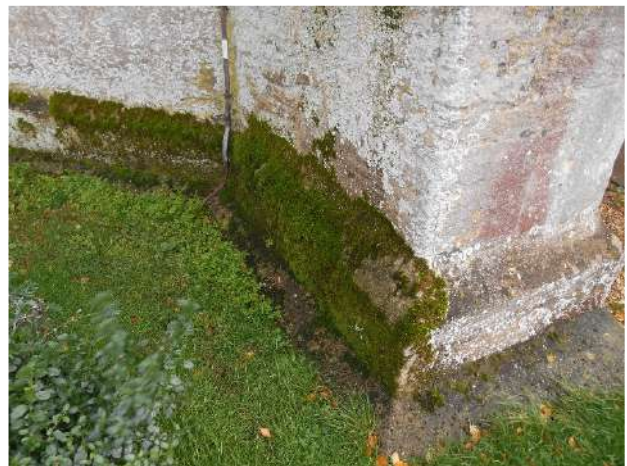
Example of moss growth to external wall plinths  
*(photo – northwest tower buttress)*

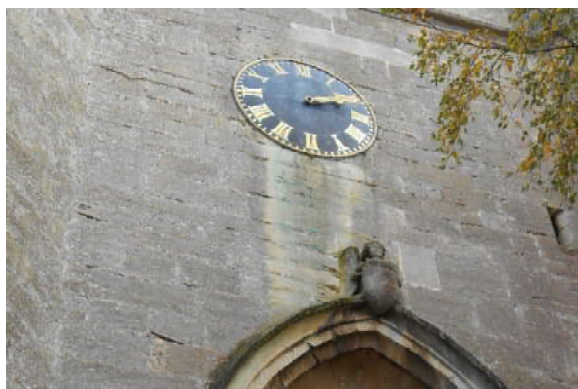
Staining below tower clock face

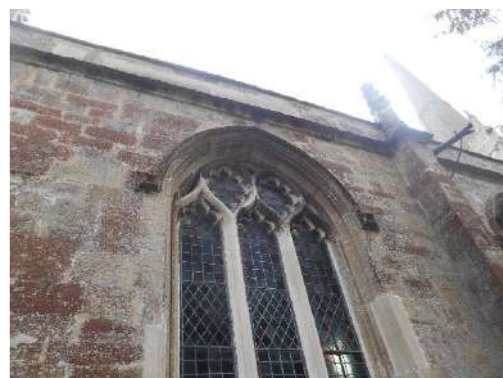
Potential open joints and displacement to hood moulding over north aisle window

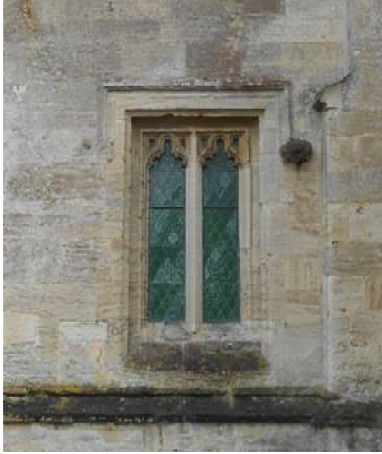
Partial loss of hood mould and stop to north porch west window

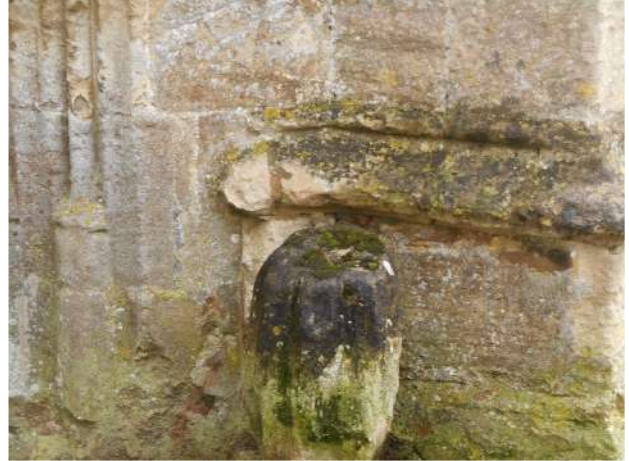
Spalling/localised loss of detailing to north porch plinth (nw buttress)

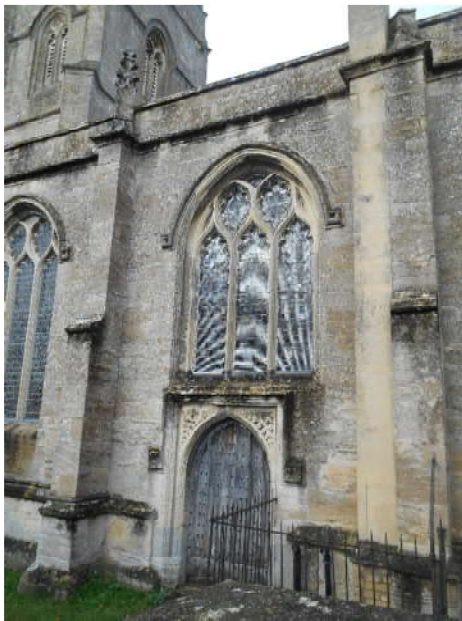
- 3.42 South elevation – there are open joints and loss of moulding to the underside of the hood moulding over the south door. The open joint should be repointed in an appropriate lime mortar, and if the door is to be brought back into a fuller use it may be desirable to reinstate the missing sections of moulding. **C**

Erosion/spalled sections of hood mould over south door and open joints/movement towards head of redundant boiler chimney

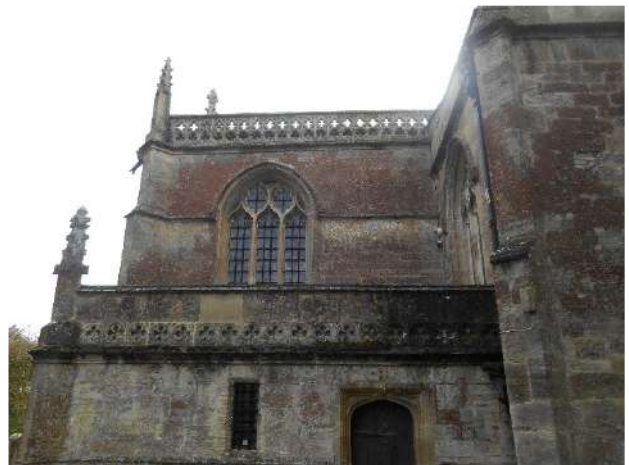
Chancel north elevation – potential signs of early softness to mortar joints east of window arch

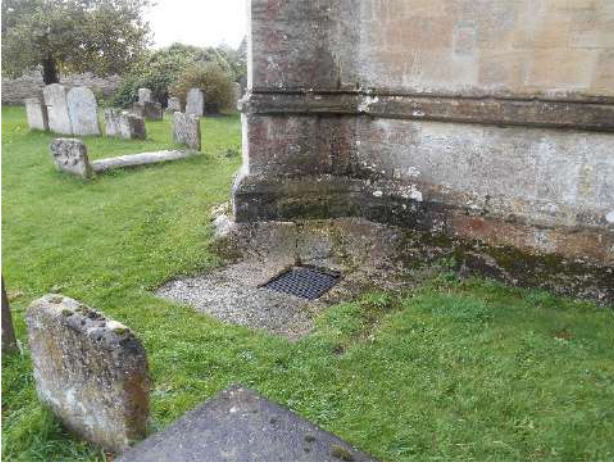
Moss becoming established and cracking/open joints to mortar flaunching and base of chancel east gable

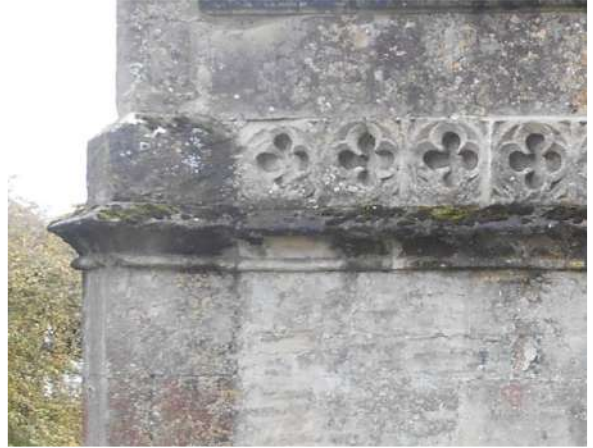
Pierced parapet block (lhs) to vestry north badly weathered

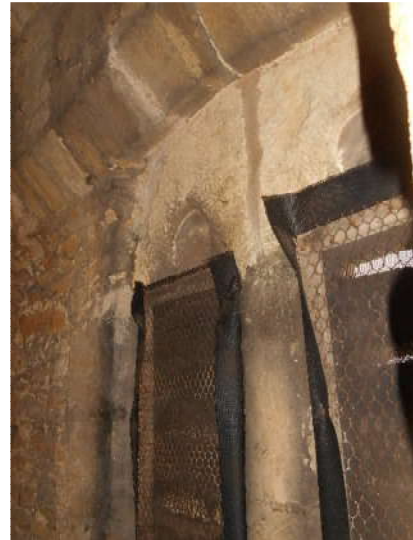
Corroding chicken wire covers to inside face of belfry louvres (to stop birds accessing the space)

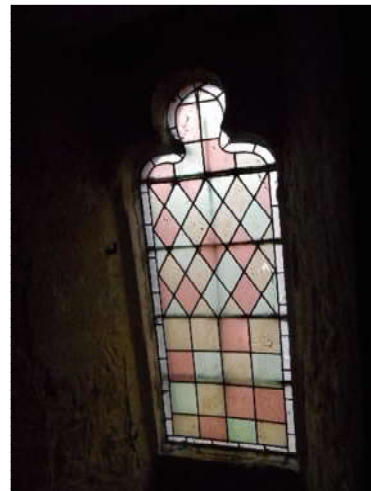
Damage to clock chamber window

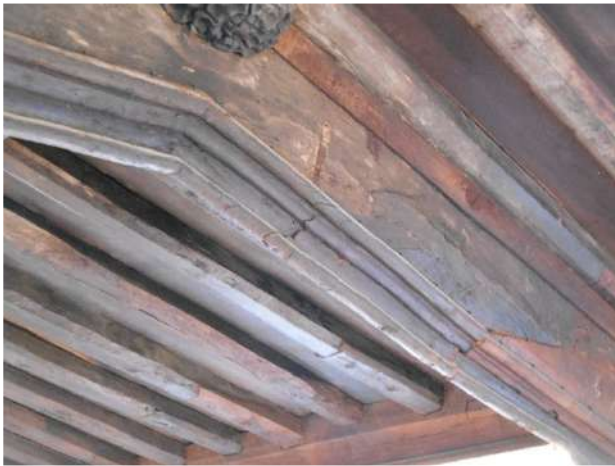
Previous repairs to nave ceiling

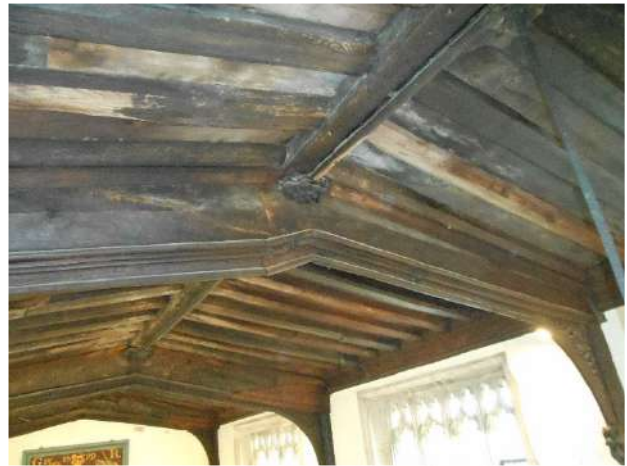
Staining (historic) to nave ceiling

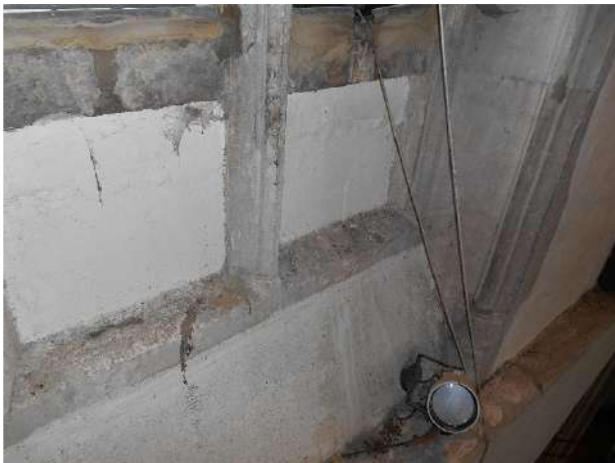
Example of water staining to painted panels below clerestory windows

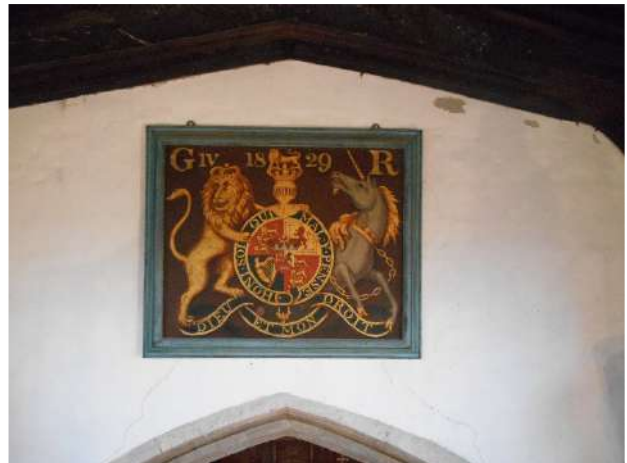
Failed decorations to nave east gable and cracking in plaster above chancel arch stone detailing

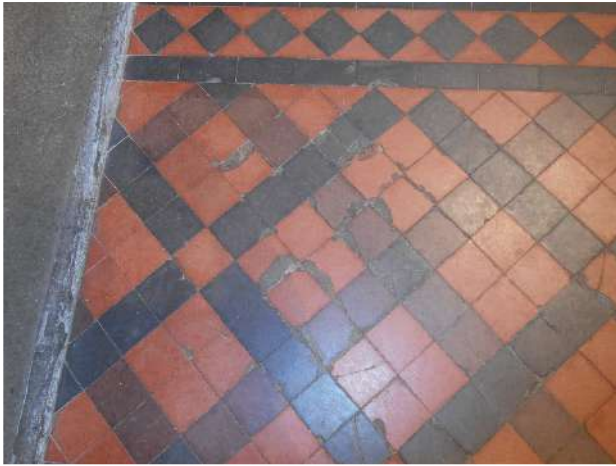
Example of damaged tiles to Nave floor (photo taken in front of chancel step)

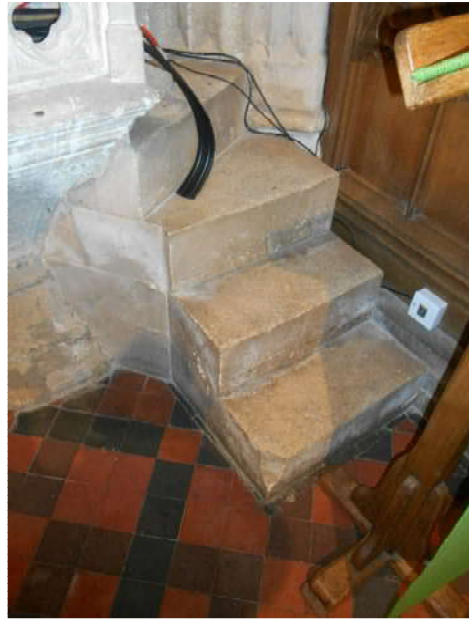
Damage (historic) to pulpit step

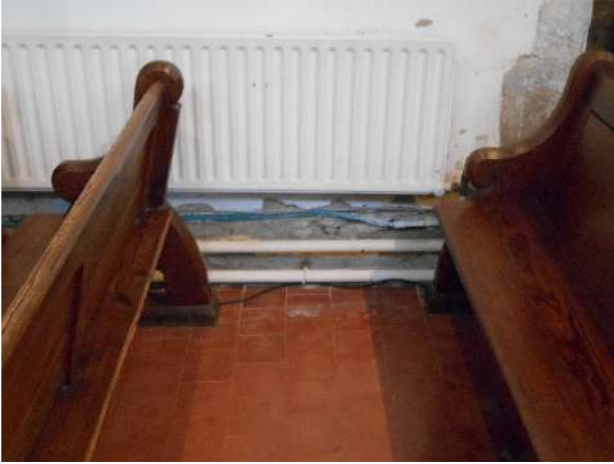
Example of plaster damage to base of south wall to south aisle

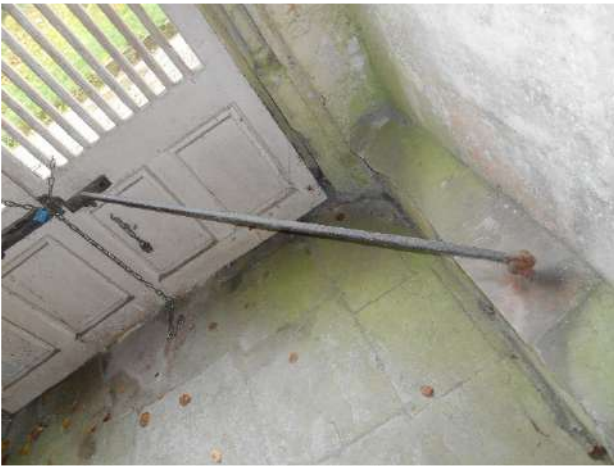
Algal staining to floor and lower wall areas of north porch – as well as failures/wear to decorative finishes

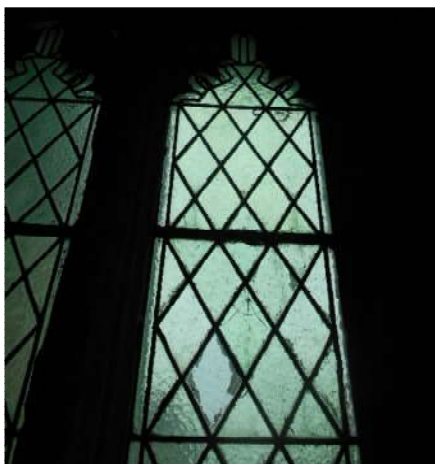
Damage to north porch window quarries (likely cause vandalism)

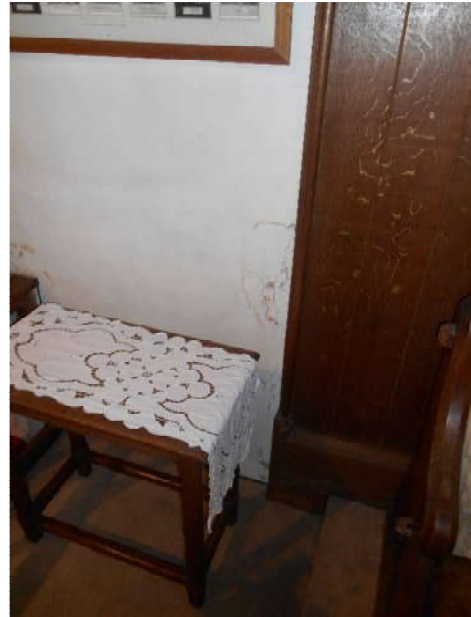
Damage to decorative finishes and wall plaster in Chancel (north side)

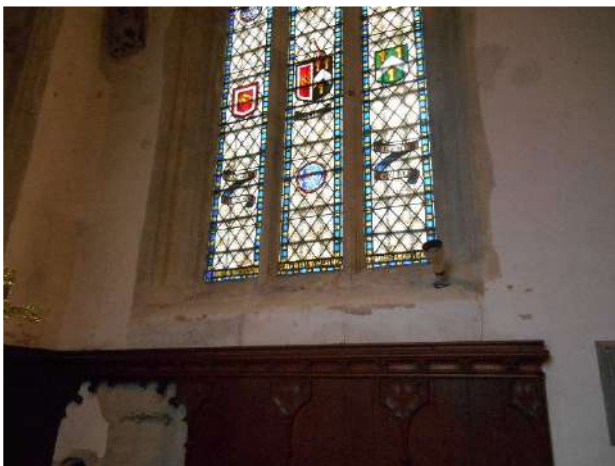
Damage to decorative finishes and wall plaster in Chancel (south side)

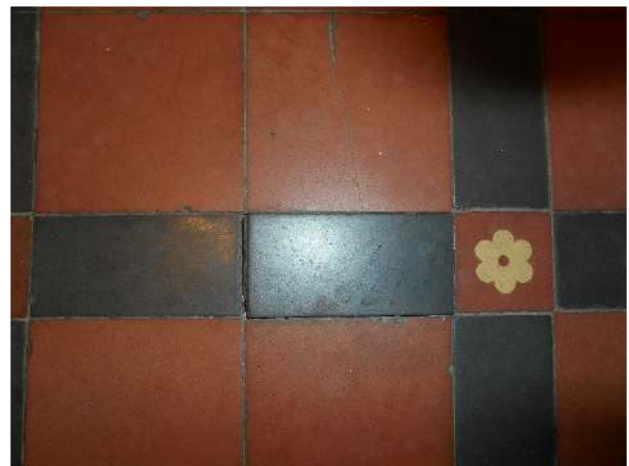
Loose tile to chancel floor

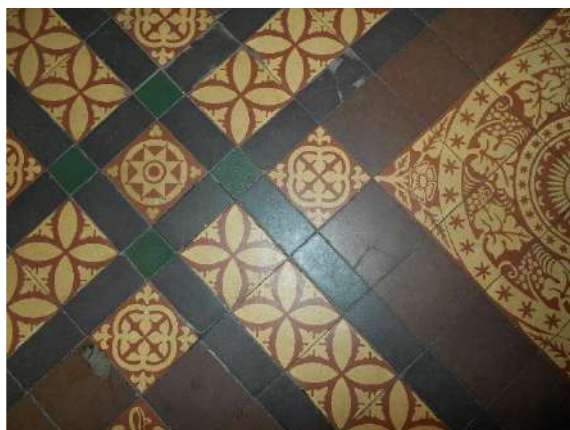
Broken/loose tiles chancel floor near sanctuary step

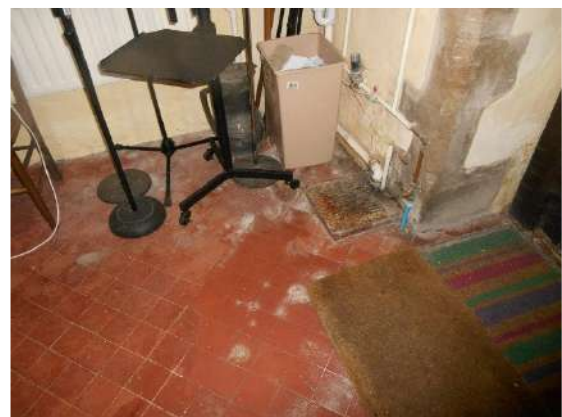
Staining/damage to vestry floor tiles

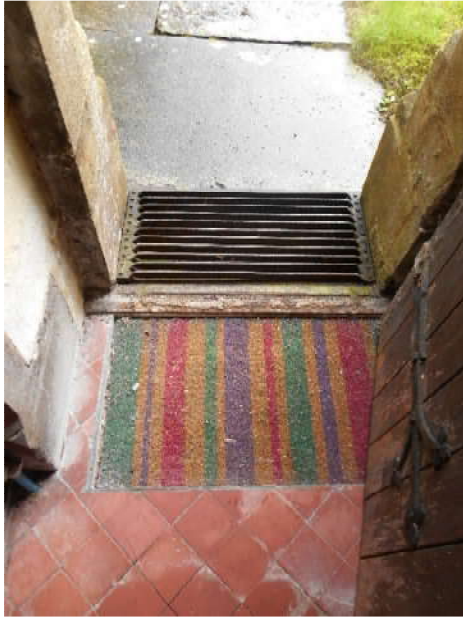
Corroding threshold to vestry external doorway

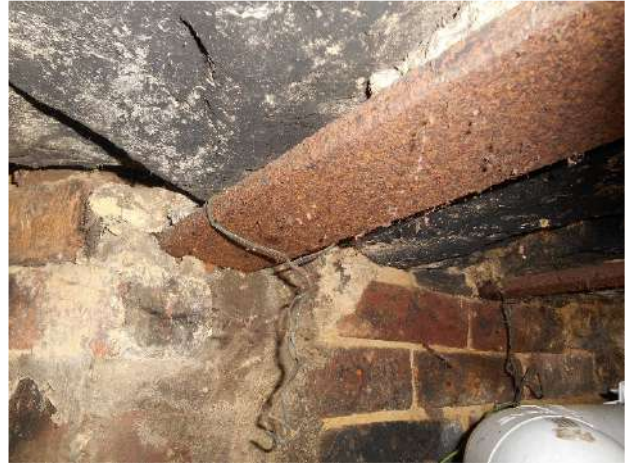
Corroding metal bars to boiler room ceiling and open joints between bar and ceiling

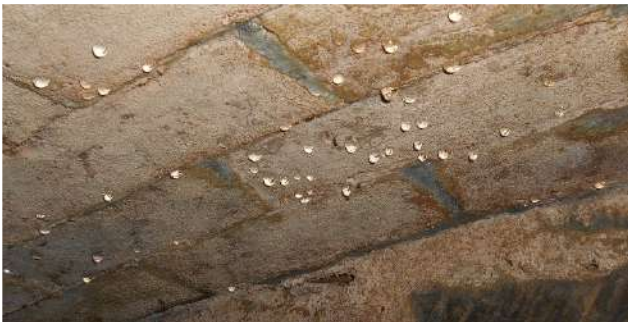
Water dripping from boiler room ceiling

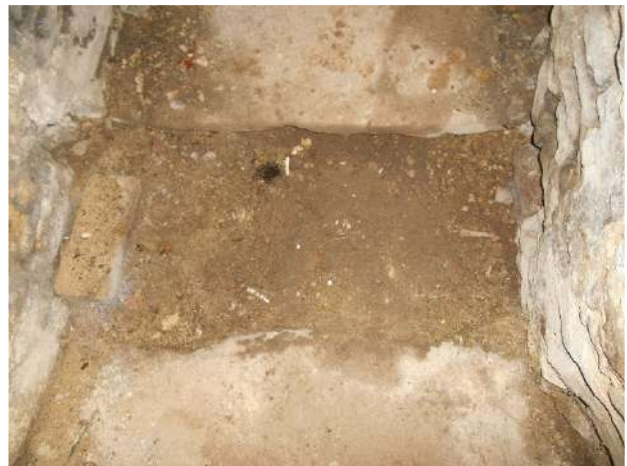
Dampness to floor

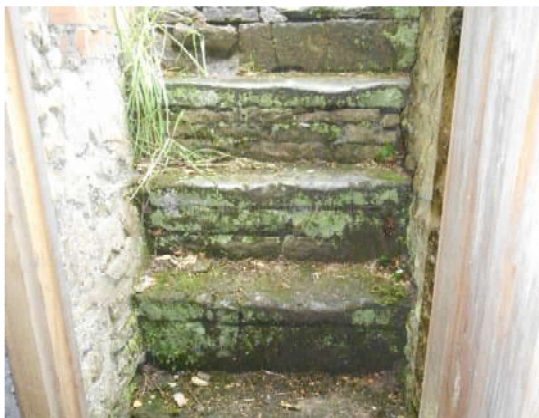
Vegetation, algae, debris and open joints to boiler room access steps

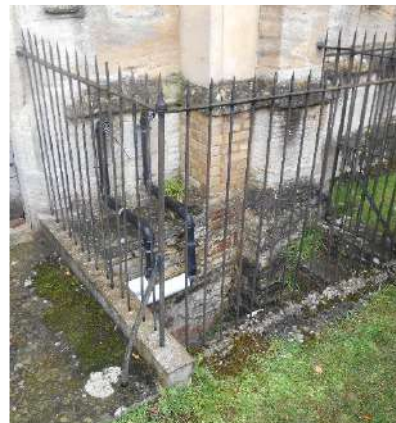
Corroding railings and gate around boiler room access steps

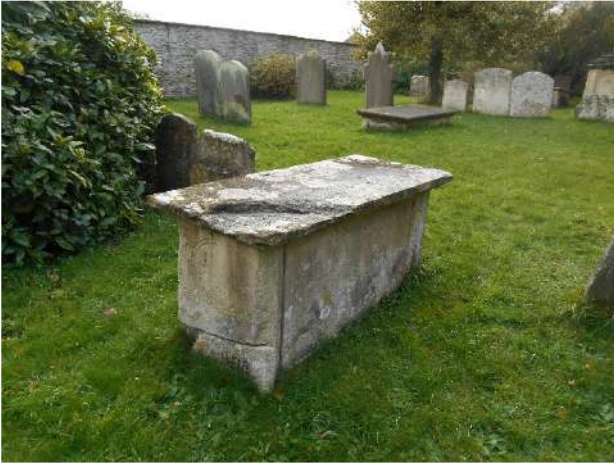
Example of condition of some chest tombs in churchyard  
(photo south side of churchyard)

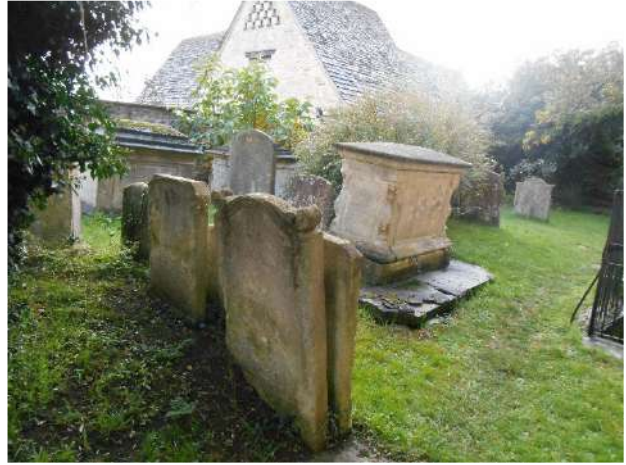
Example of uneven ground levels impacting upon  
condition of some chest tombs in churchyard  
(photo south side of church, by boiler room railings)

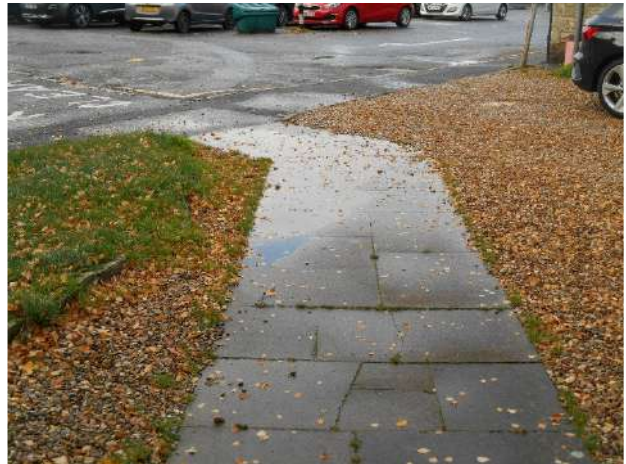
Modern flagstone path leading to west door liable to  
flooding and water running into porch
