## **Church of St Lawrence, Lechlade-on-Thames, Gloucestershire**

**An Archaeological Watching Brief Report**

**For Nigel Jones on behalf of  
Lechlade PCC**

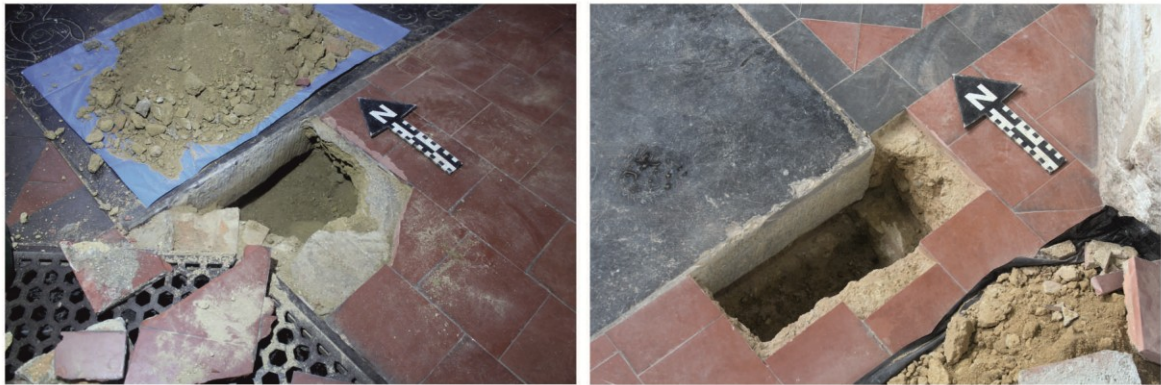
- 6.2 Test pits 1 and 6 were located at the west end of the north aisle next to a black marble ledger [3] commemorating Edward Bathurst †1677. The ledger measures 1.95m x 0.99m x 0.14m thick. The ledger was formerly set in the central aisle of the nave, being moved in the 1882 reordering. Test pit 1 was located at the southwest corner of the ledger, next to a heating duct, whilst Test pit 6 was located at the southeast corner near to the western column of the north arcade.

- 6.3 An *in situ* block of limestone [26] was revealed at the base of Test pit 6 at a depth of 0.15m, this is most likely part of the base of the western column of the north arcade (Figs 3 and 4).

Fig.3 Views of Test pit 1 (left) and Test pit 6 (right, showing ledger and limecrete screed, with pier foundation, scale 0.15m

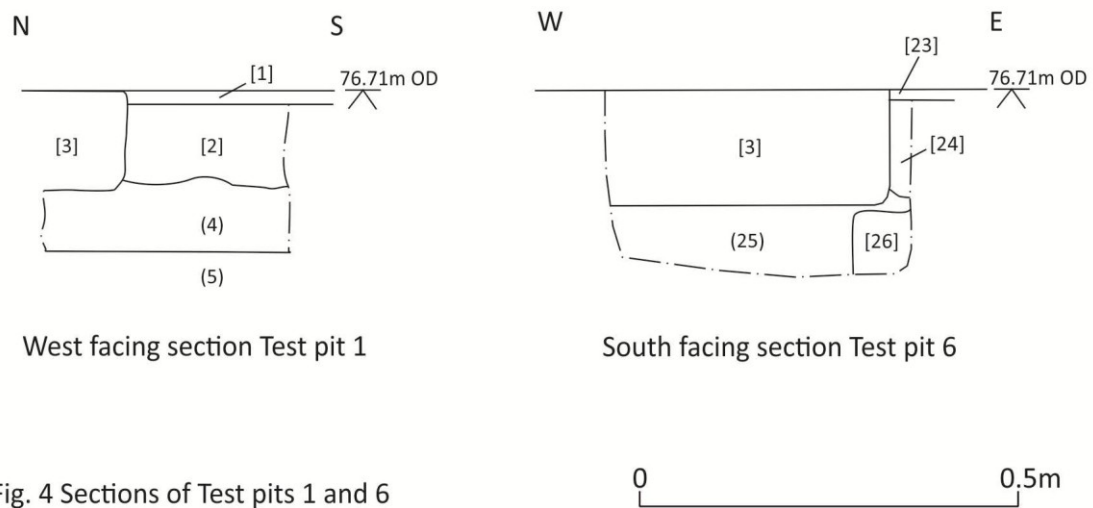
Fig. 4 Sections of Test pits 1 and 6

- 6.4 At the west of the ledger the adjacent heating duct was constructed from red bricks, with a metal grille. A later of trampled grey sandy silt (5) was located at the base of Test pit 1 at a depth of 0.21m (76.50m OD); this may be a trample layer from the construction of the ducting, or from works carried out prior to the installation of the Victorian floor.

- 6.5 Layers of loosely compacted yellow-orange dirty sandy gravel (4, 25) were recorded in both test pits, lying above the sandy silt in Test pit 1 and sealing the column foundation in Test pit 6 and the heating duct. The ledger was laid on the gravel and sand. The sandy gravel was

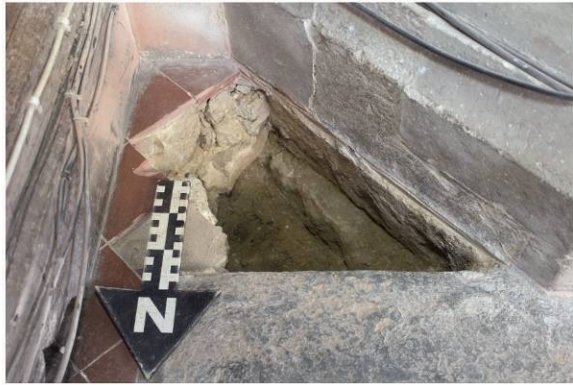
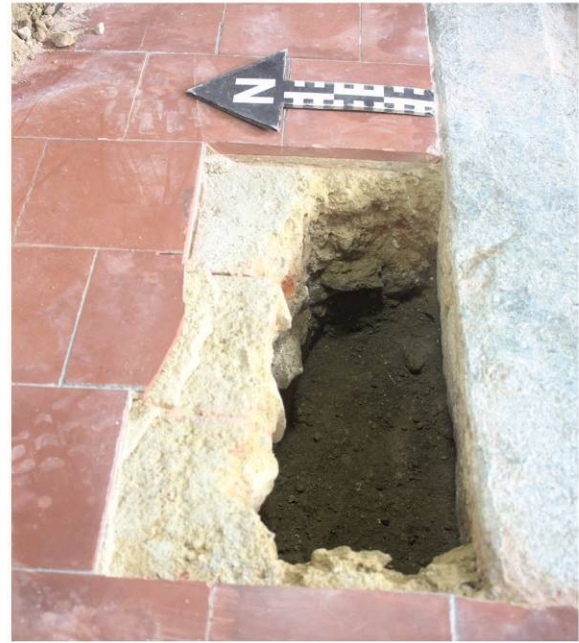
- 6.8 The offset foundation of the eastern pier [9] of the north arcade was revealed in Test pit 2 at a depth of 0.17m (Figs 5 and 6). The foundation was of roughly dressed limestone, the lowest block of the pier was in dressed limestone, with finely dressed stone above the current floor level.

Fig. 5 Views of Test pit 2 (left) and Test pit 5 (right, showing ledger and limecrete screed, with pier foundation, scale 0.15m

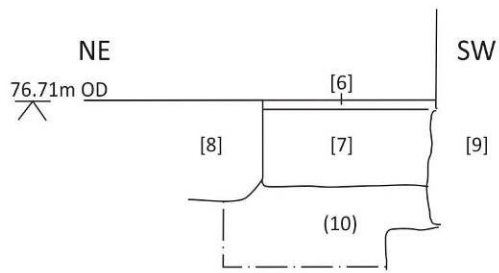
North west facing section Test Pit 2

- 6.9 Layers of loosely compacted yellow-orange dirty sandy gravel (10, 22) were recorded in both test pits, sealing the column foundation in Test pit 2. The ledger was laid on the gravel and sand. The sandy gravel was sealed in both Test pits by a 0.1–0.11m thick layer of lean-mix limecrete screed [7, 21] which was laid around the ledger. The screed was topped by the present floor surface of earthenware tiles [6, 20] with a surface at 76.71m OD. The ledger was partially overlain by a Victorian stone piecing at the base of the pier.

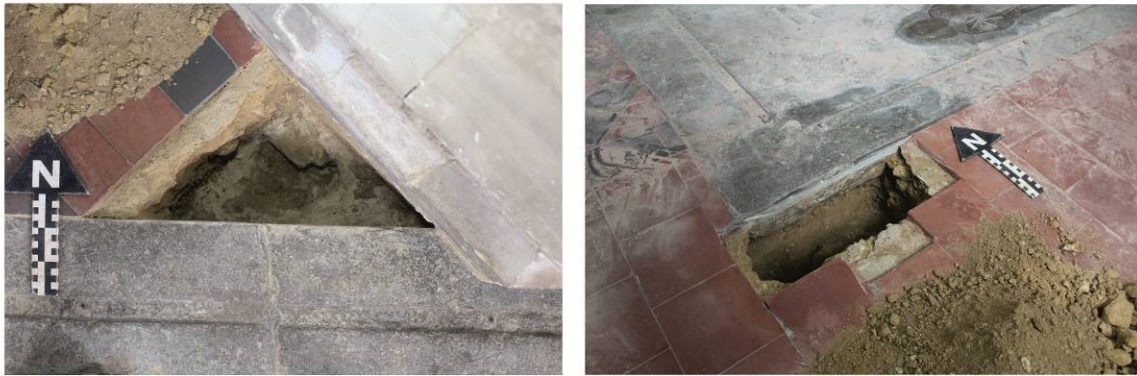
- 6.12 The offset foundation of the eastern pier [13] of the south arcade was revealed in Test pit 3 at a depth of 0.13m (Figs 7 and 8). The foundation was of roughly dressed limestone, the lowest block of the pier was in dressed limestone, with finely dressed stone only above the current floor level. The foundation was sealed by a layer of lime mortar construction trample (15).

Fig. 7 Views of Test pit 3 (left) and Test pit 4 (right, showing ledger, limecrete screed and pier foundation, scale 0.15m

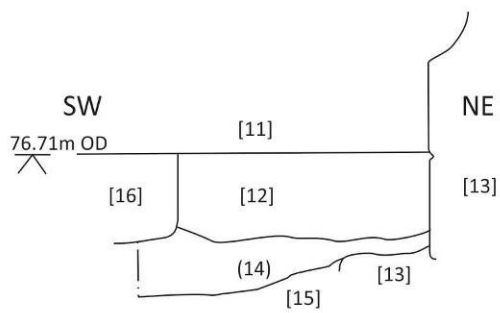
Southeast facing section Test pit 3

- 6.13 Layers of loosely compacted yellow-orange dirty sandy gravel (14, 19) were recorded in both test pits, sealing the column foundation in Test pit 3. The ledger was laid on the gravel and sand. The sandy gravel was sealed in both Test pits by a 0.1m thick layer of lean-mix

limecrete screed [12, 18] which was laid around the ledger. The screed was topped by the present floor surface of earthenware tiles [11, 17] with a surface at 76.71m OD. The ledger was partially overlain by a Victorian piecing at the base of the pier.
