Structural Engineering Stage 3 Report

St Lawrence Church, Lechlade – Project Inspire

Issuing date: **14 October 2022**

Document reference: 0117/REPORT 01 rev A

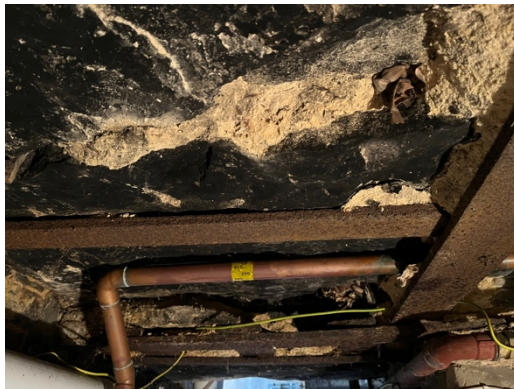
Image 6.2

In many cases there is a gap between the metal plate and the underside of the stone pavers. The metal plates also exhibit surface corrosion. In one corner, the brickwork off which the metal straps are supported forms a brick corbel – which is not considered very robust. There could be other defects with the floor which are not obvious. This could be assessed in more detail by lifting the tiled floor finishes to expose the pavers from above.

The existing floor finishes above are showing no obvious signs of distress. This suggests the stone pavers are performing adequately to support the use of the floor above. This however has probably been restricted to people walking about or sitting on pews – which generate relatively limited imposed loads. The existing floor is unlikely to be able to support heavy concentrated loads – such as those set out in table 6.1 above.

If a new raised floor was not to be introduced, simple repair measures could be carried out by introducing a mortar bedding to fill the gaps between the pavers and metal plates, plus cleaning and protecting the metal plates with a corrosion protection paint. This is shown as option 1 on drawing 0117/20. Such an approach would still mean the floor has a restricted use - similar to how it has been used before - but the measures would improve the overall robustness of the floor.

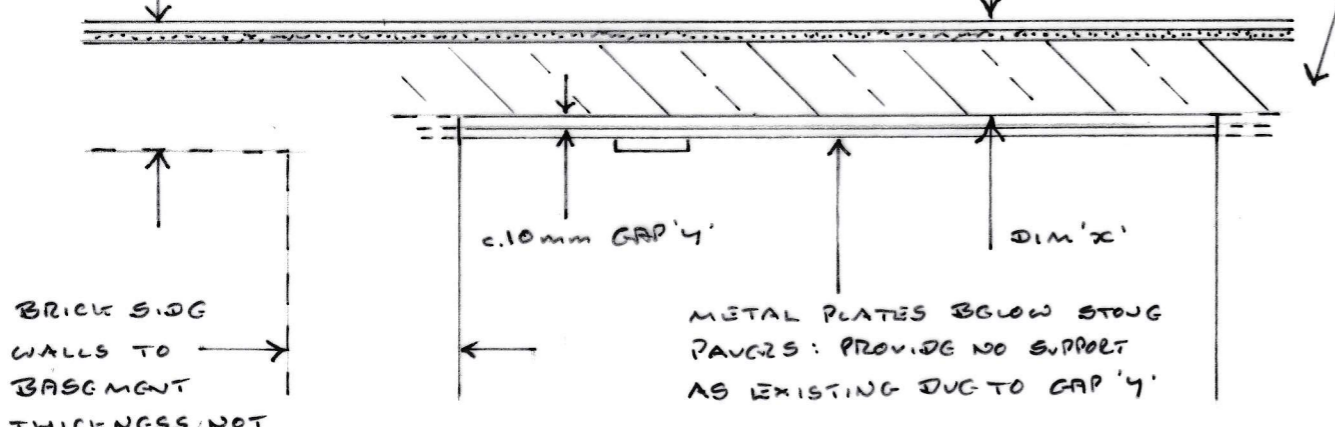
EXISTING FLOOR DETAIL OVER BASEMENT

ARCHAEOLOGICAL WATCHING BRIEF REPORT DESCRIBES GENERAL FLOOR BUILD UP AS CLAY TILES ON BEDDING MORTAR OVER CONCRETE SLAB (THICKNESS VARIES 100-150mm) OVER LOOSELY COMPACTED SANDY GRAVEL.

STONE PAVERS VISIBLE ON SOFFIT OF CEILING TO BASEMENT AREA. MEASURED SURVEY INDICATES DIMENSION 'x' = 120mm.

JUNCTION OF FLOOR TYPES WITH WALL UNDER NOT CLEAR.

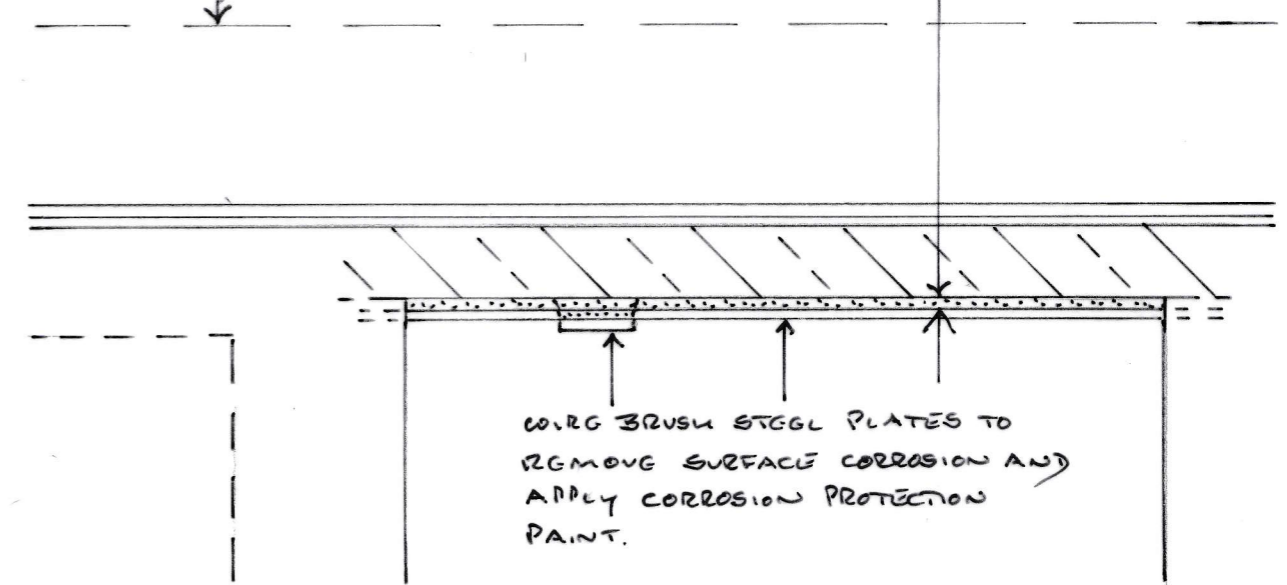
REPAIR OPTION 1: REPAIR EXISTING FLOOR

NEW RAISED FLOOR IMPOSES NEW DEAD LOAD OF C. 2.5kN/m²

INTRODUCE DRY MORTAR PACKING TO FILL GAP 'y' SO EXISTING STEEL PLATES ASSIST SUPPORT OF STONE PAVERS

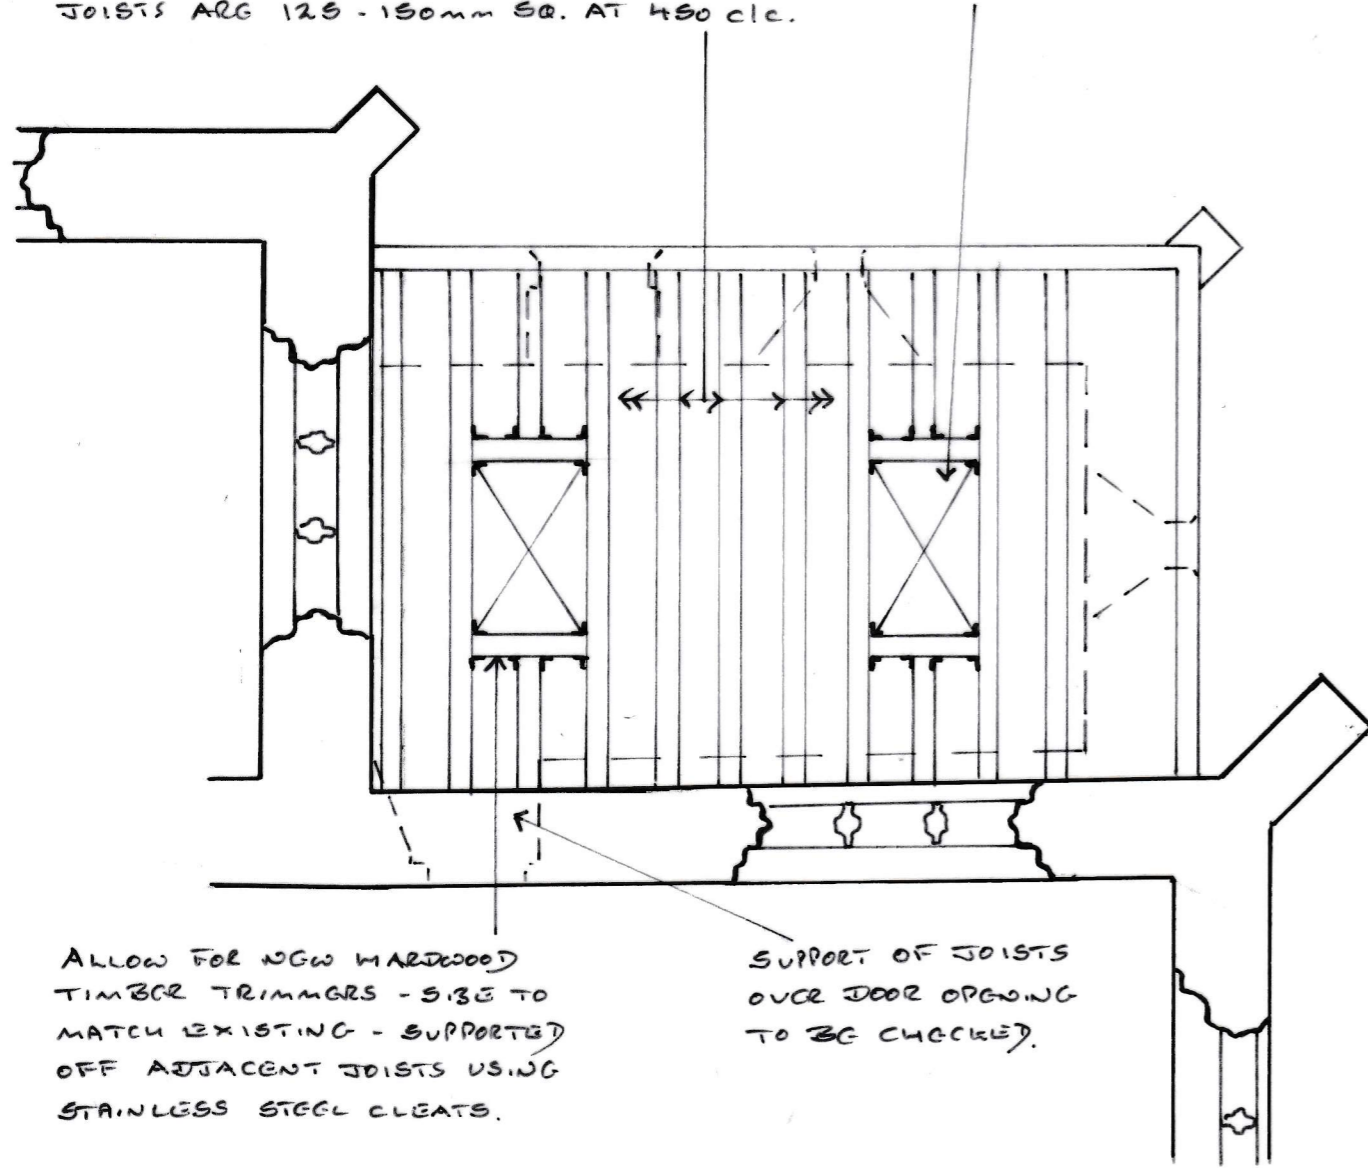
LAYOUT OF EXISTING ROOF STRUCTURE IS CONJECTURAL AT THIS STAGE AND IS ASSUMED TO CONSIST OF HARDWOOD TIMBER ROOF JOISTS SPANNING NORTH-TO-SOUTH. DESIGN ASSUMES EXISTING JOISTS ARE 125 - 150mm SQ. AT 450 c/c.

NEW ROOFLIGHTS: POSITIONS TO BE DETERMINED TO SUIT LAYOUT OF ROOF JOISTS TO LIMIT IMPACT ON HISTORIC FABRIC.

ALLOW FOR NEW HARDWOOD TIMBER TRIMMERS - SIZE TO MATCH EXISTING - SUPPORTED OFF ADJACENT JOISTS USING STAINLESS STEEL CLEATS.

SUPPORT OF JOISTS OVER DOOR OPENING TO BE CHECKED.

EXISTING CEILING TO VESTRY IS TIMBER-PANCELLED. TO LIMIT DAMAGE TO PANCELLING, IT IS RECOMMENDED THIS IS ENTIRELY REMOVED TO ALLOW ROOF STRUCTURE TO BE INSPECTED. ROOFLIGHT POSITIONS AND SIZES CAN THEN BE CONFIRMED. INVESTIGATIONS TO BE CARRIED OUT DURING STAGE 4 DESIGN.
