St Lawrence Church

LECHLADE-ON-THAMES

Supporting document to the faculty submission in response to the DAC Report dated 31st March 2022

Proposals to construct a new stone floor in the nave

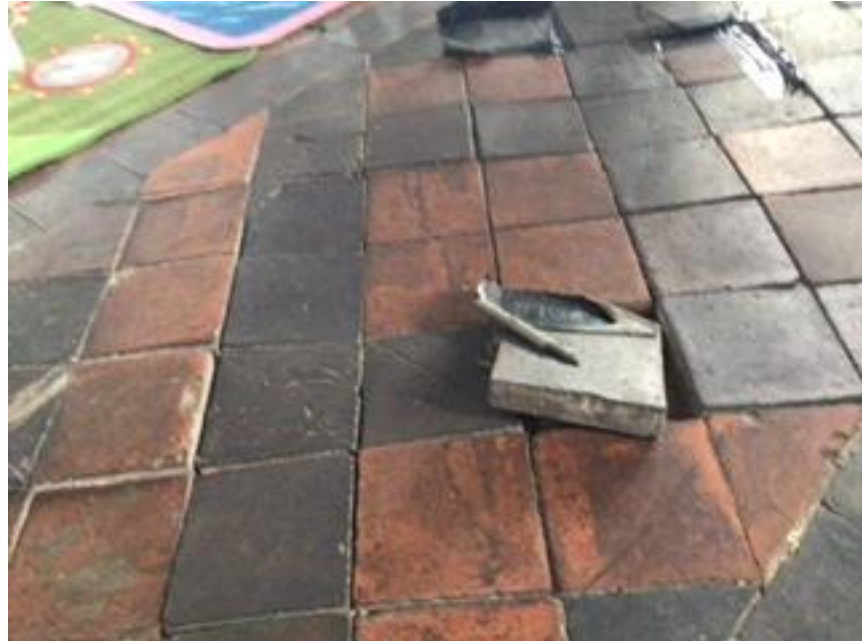
St Mary the Virgin,
Wheatley – the tiles are
one inch thick

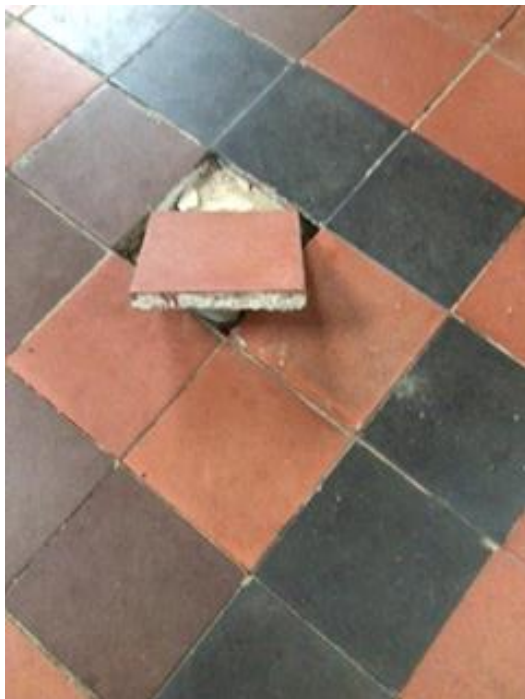
St Lawrence Lechlade – the tiles in the aisles are ½
inch thick. Tiles under the pews are thinner

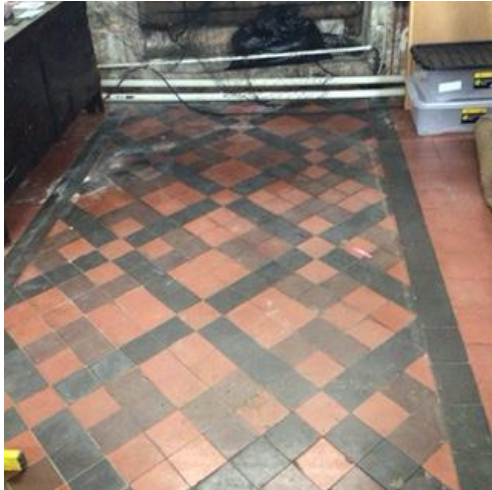
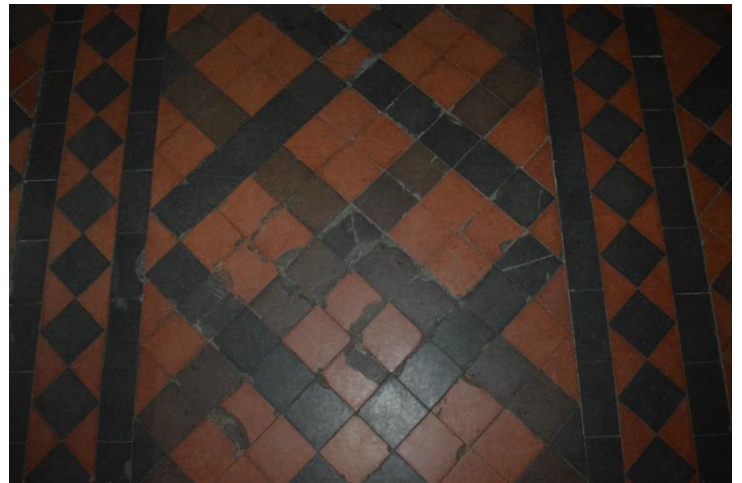
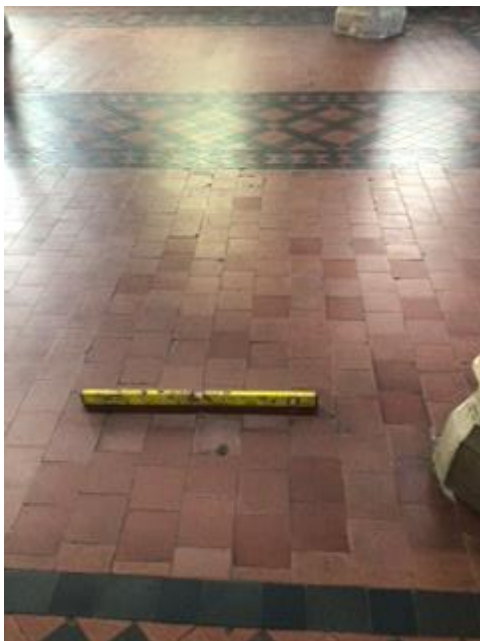
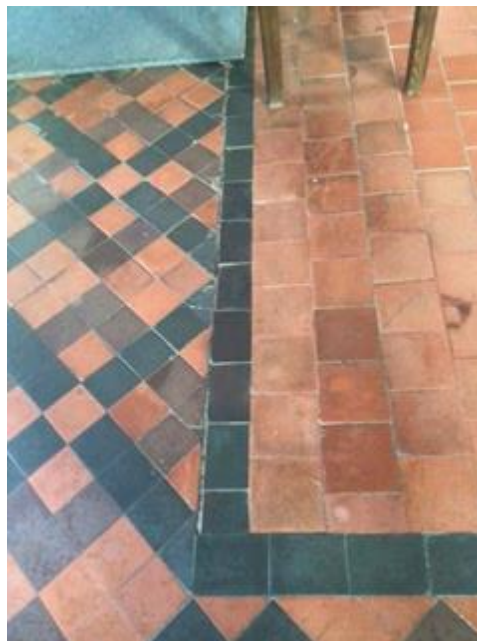
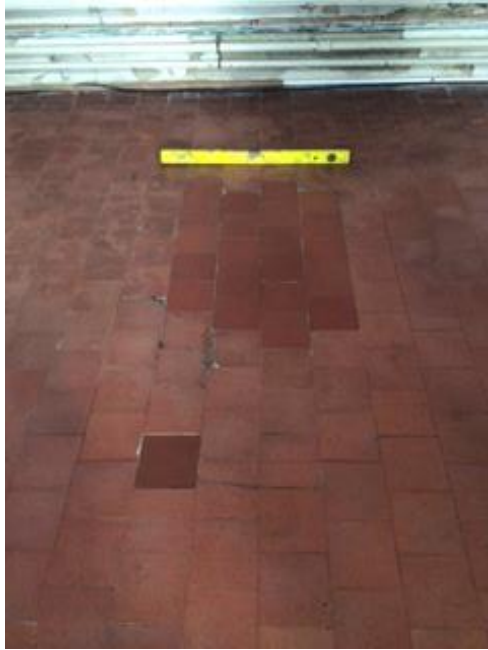
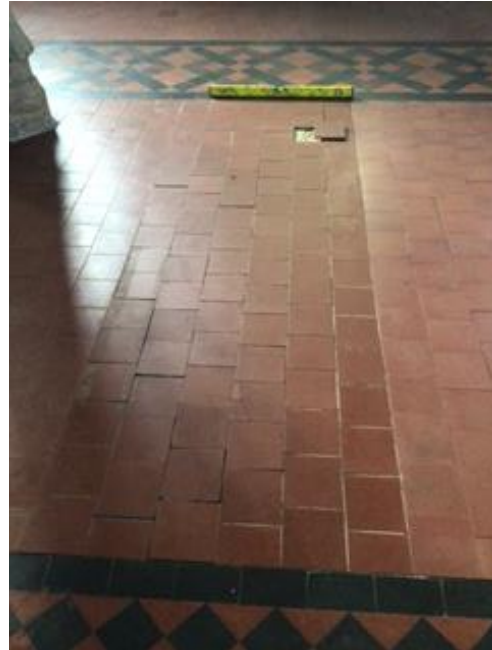
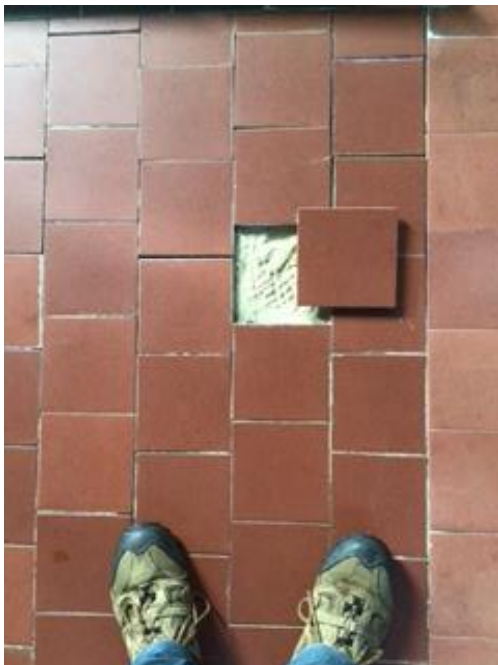
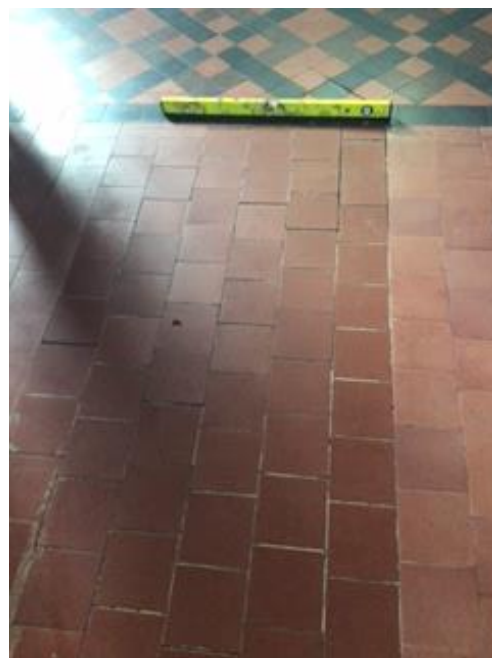
Appendix C – St Lawrence church: photographs of the existing quarry tiles in the nave

There is a long history of tiles becoming loose in several places with some lifting and cracking.¹¹ Remedial works have been carried out over many years, but the problem continues and there is a risk of tripping over the loose or worn tiles.

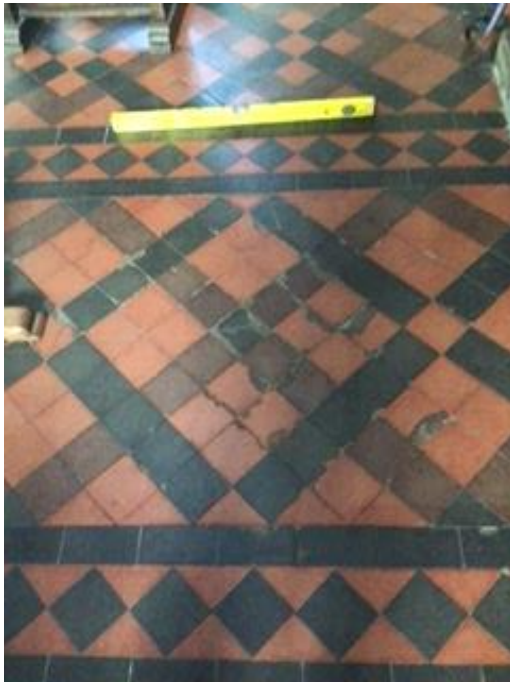
Left: typical damage to clay tile from point loading failure

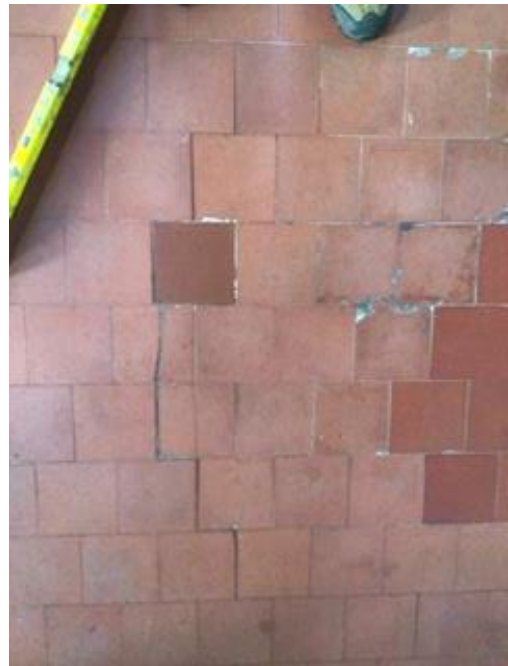
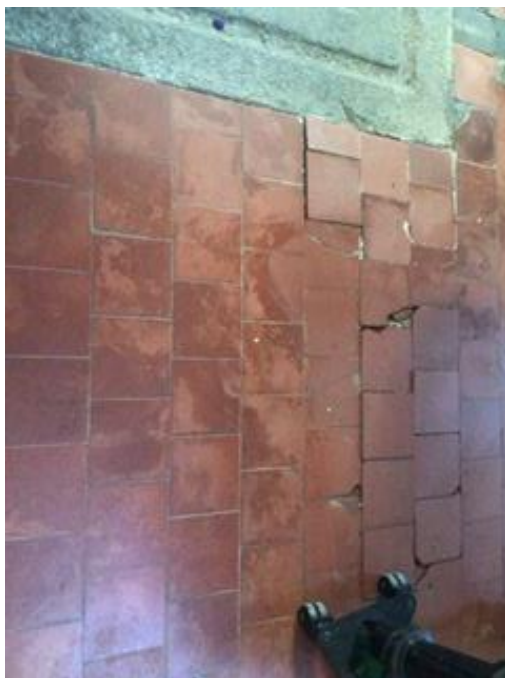
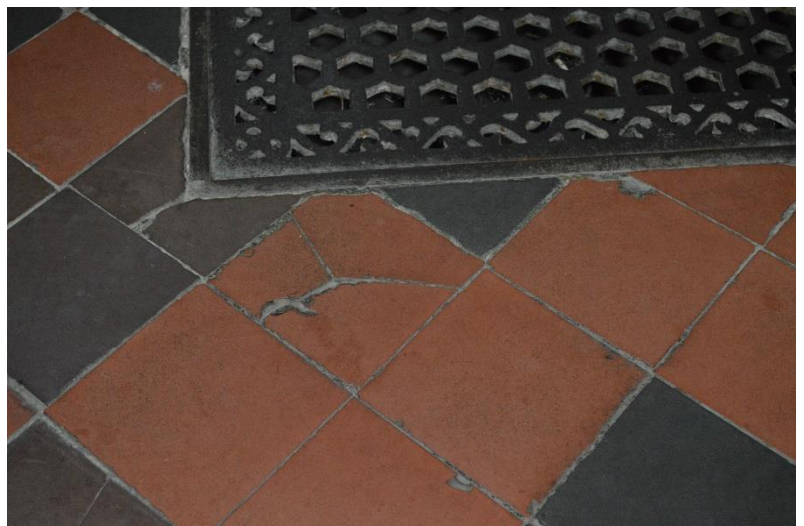
Many of the tiles are damaged by point loading (see below) or by a lack of adhesion to the limecrete floor.
