## Project Inspire

### Restoration and Reordering: Ledgerstones

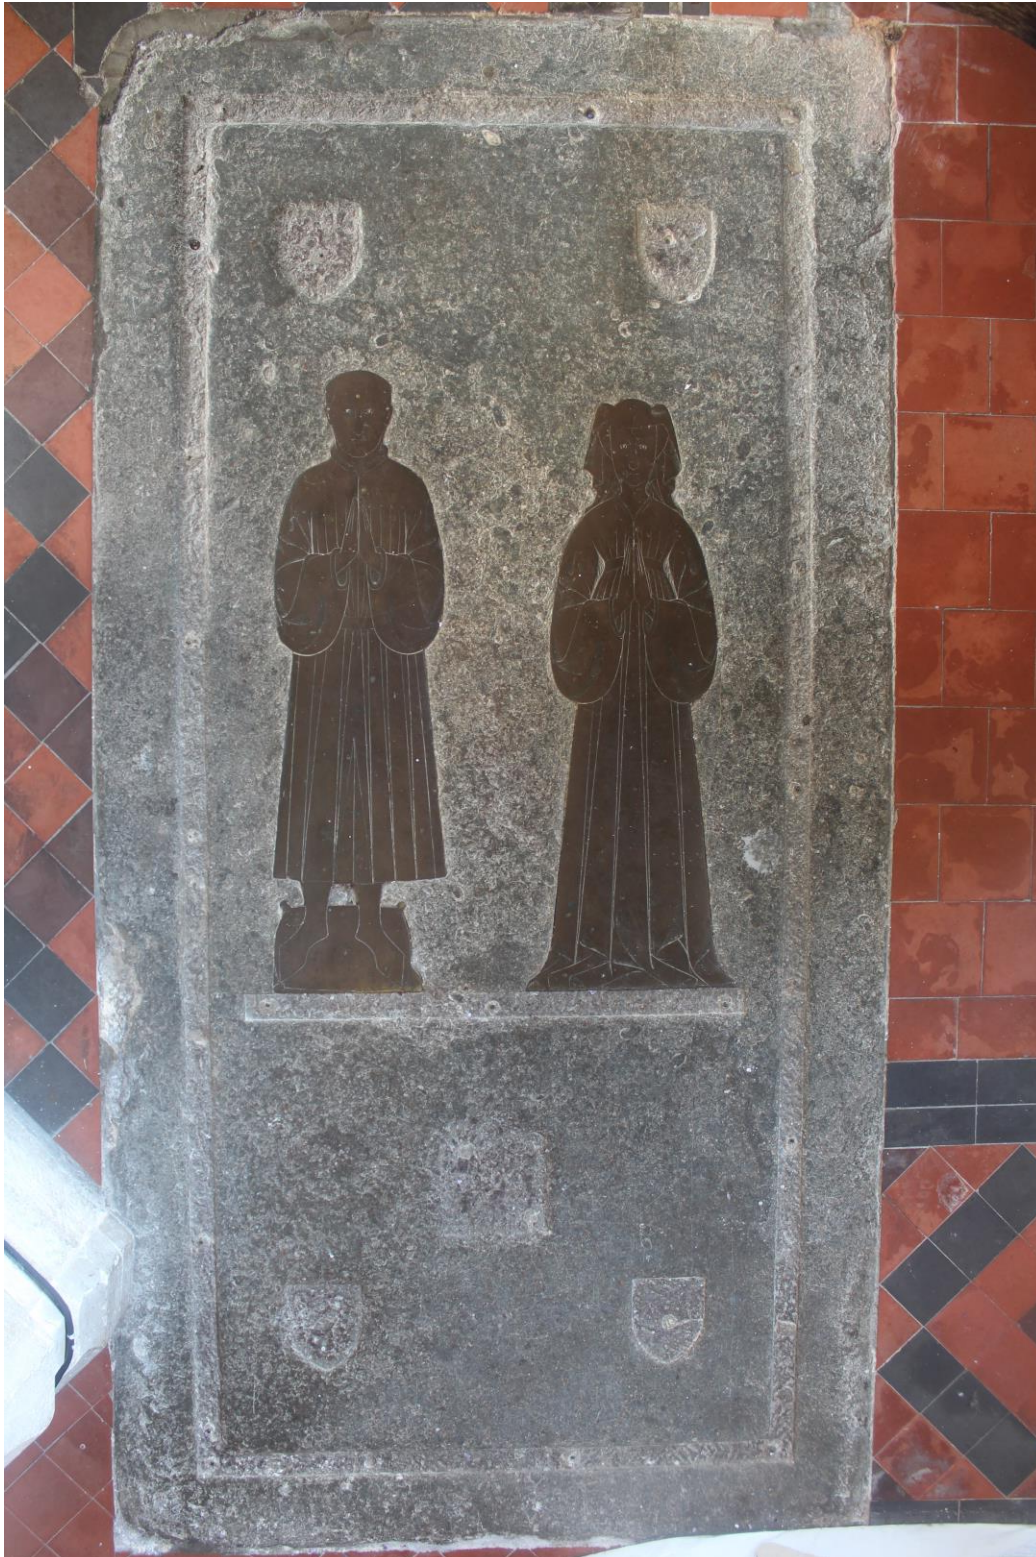
**The Townsend Ledgerstone**

3. There are three ledgerstones in the existing floor:
  - (i) In the north aisle, there is a limestone (thought to be forest marble<sup>2</sup>) memorial slab commemorating John Townsend and his wife Ellen with their brasses. He died in 1458. On inspection, there may have been brass edgings although these were probably removed some time ago. Drawings suggest that this ledger has been relocated from the nave. Geophysics show no evidence of any burial underneath<sup>3</sup>. The stone is near where the grand piano is located, we try and reduce the risk of potential loading damage. The slab is about 140 mm thick and bedded on sandy gravel. See Photo 1.

6. The Townsend ledgerstone: this has been laid adjacent to and inset by about 80mm into a column in the north aisle. To lift this ledgerstone there is a need to remove a piece of stone at the base of the column to allow a vertical lift. The piece of stone can then be replaced. This method is based on the advice from our stonemason. The archaeological investigations show that the stone is bedded on sandy gravel and it would be feasible to excavate under the slab to install lifting straps. The relocation position has not been finalised but we envisage this to be nearby in the north aisle.

9. For the Townsend and Hitchman ledgerstones, our initial view on the options set out in paragraph 4 above is that burying the stones loses the opportunity for the church community and visitors to view the ledgerstones and in particular the brasses. Providing a thick glass cover to the two stones will allow them to be seen although there is a concern about the need to prevent any deterioration to the brasses and the long-term sustainability of the solution. As both stones are not in their original positions within the church, we are coming to the view that these should be relocated in alternative positions within the new floor, bearing in mind the need to ensure that the brasses are not subject to foot traffic or loading.

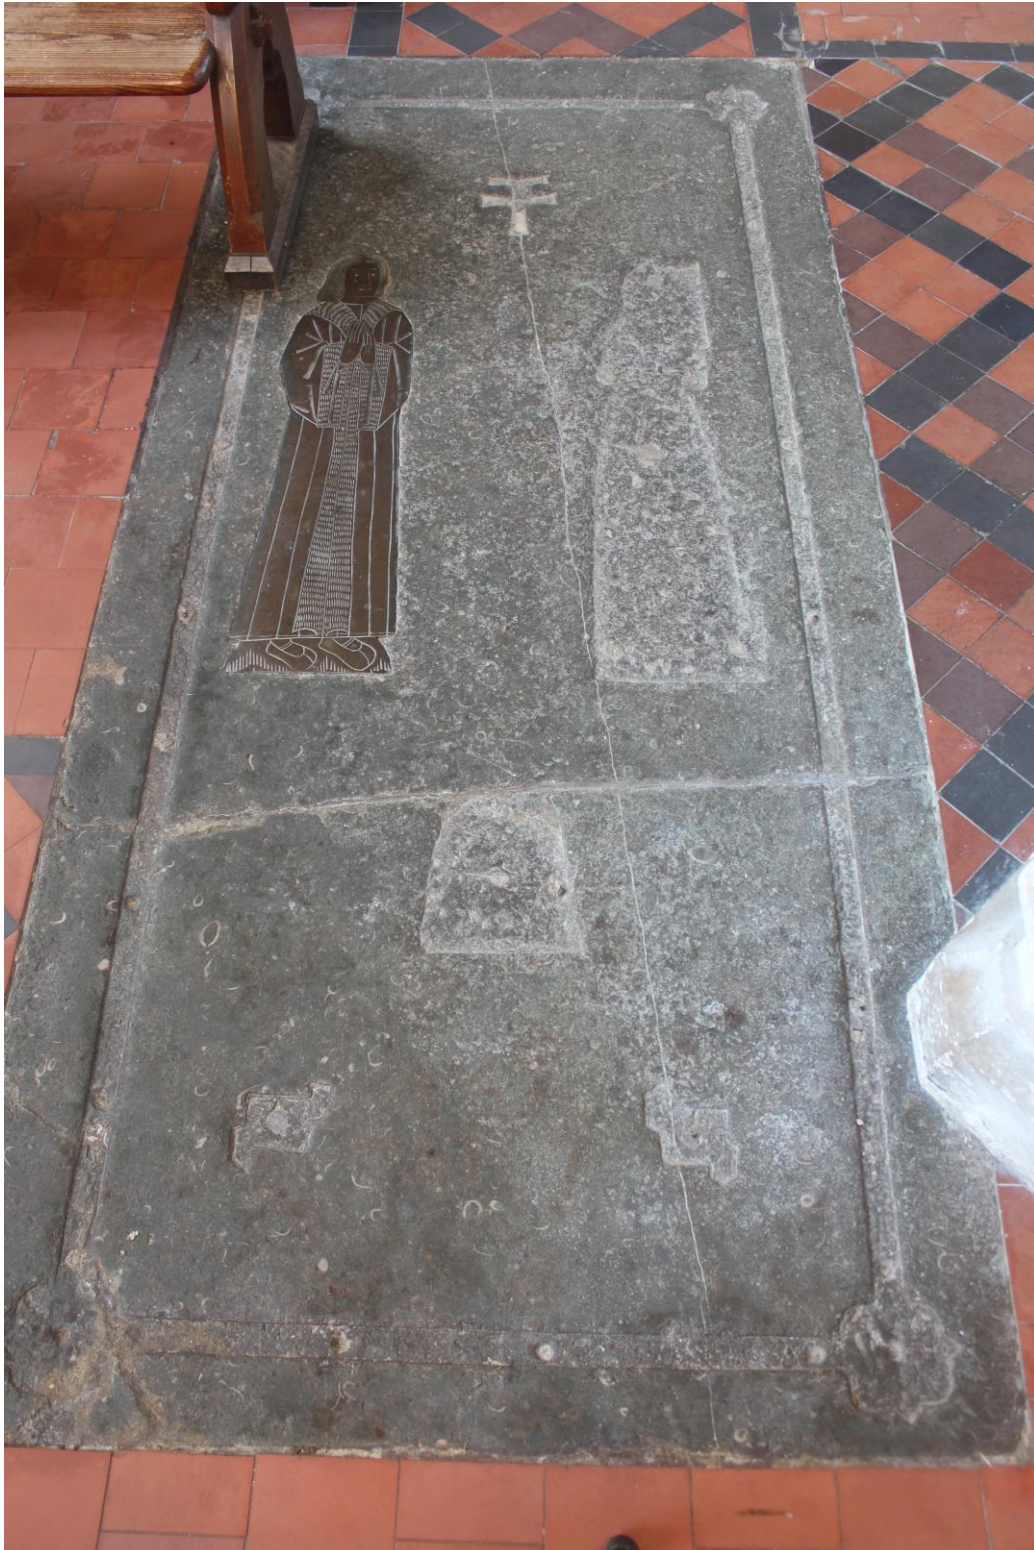
**The Hitchman Ledgerstone**

- (ii) In the south aisle, a similar limestone (similarly thought to be forest marble) memorial slab is to the memory of Robert Hitchman who died in 1510. His wife's brass is missing. Drawings show that this ledger has also been relocated from the nave and there is no evidence of any burial underneath. The slab is about 140 mm thick and also bedded on sandy gravel. There is a crack across this ledgerstone located about one third along the stone from the east end; excavation along the side of the crack suggests this is to the full depth of the slab. There is also evidence of repairs being made; this suggests that the crack may possibly have occurred when the slab was placed in this location. The stone is located near the side chapel and subject to light foot traffic (as it has been for many years). See photo 2.

7. The Hitchman ledgerstone: this is laid in a similar way to the Townend stone being adjacent to and inset partially under a column in the south aisle. The methodology set out in 6 above applies equally to this ledgerstone. The difficulty here is that the existing stone is fractured, either when it was relocated to the existing position or after ground settlement. From one of the trial pits, it is likely that the crack extends to the full depth of the stone. There is evidence of repair work having been carried out. Our stonemason advised that it would be feasible to repair the ledgerstone, after removal using stainless steel dowels fixed into both halves of stone. While the detailed method needs to be set out and agreed, the stonemason's view is that the repair can be made without detriment to the ledgerstone. The relocation position has not been finalised but we envisage this to be nearby in the south aisle.

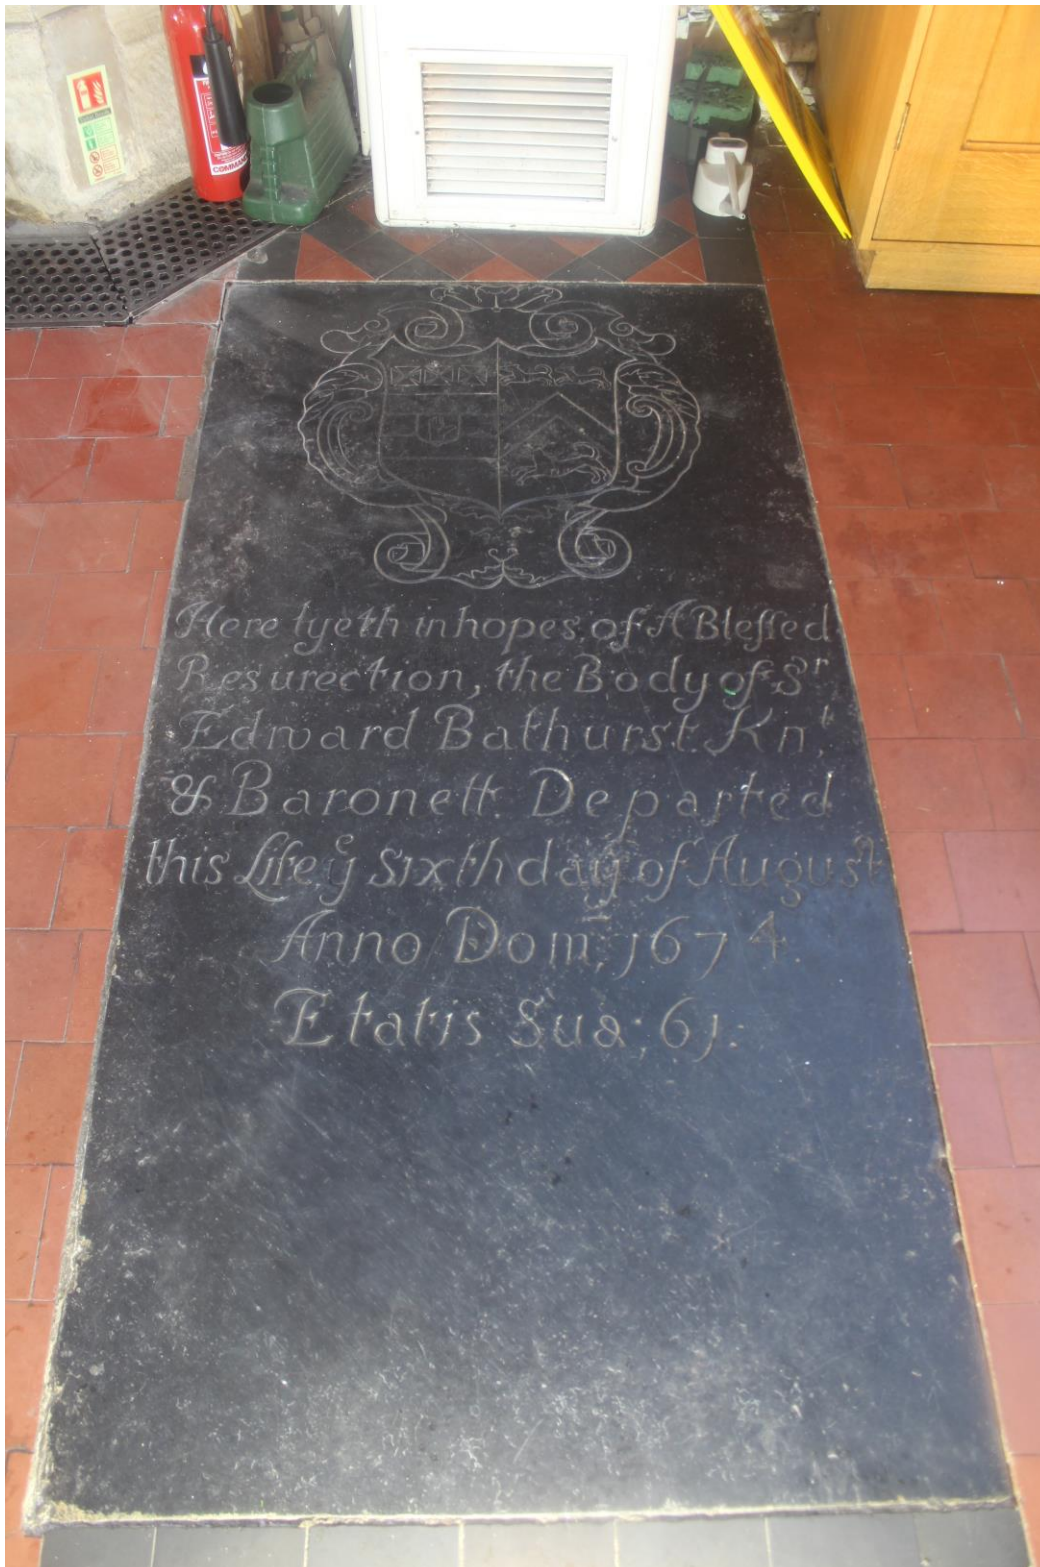
**The Bathurst Ledgerstone**

- (iii) The third, a 17<sup>th</sup> century, ledgerstone is at the west end of the north aisle and has been moved from its original location. An early photograph shows this had previously been set vertically in the sanctuary. This slab is in memory of Edward Bathurst. It is an inscribed polished black marble about 140 mm thick. There are no brasses. See photo 3.

8. The Bathurst ledgerstone: this is located in the north west of the church where we are proposing to locate toilets so there is little option but to move the stone. This stone is also bedded on a sandy gravel and it is feasible to lift. The living descendants of Sir Edward Bathurst show an interest in the memorial. We are therefore considering relocation of the ledgerstone to a more prominent position within the north porch or the new entrance lobby.

10. We have established, on advice from our stonemason, that it is feasible to lift the Bathurst ledgerstone and there is clear space around the stone to do this. The location within the reordered church would be under the proposed toilets so there is little option but to relocate. Again, the stone is not in its original position within the church and there is no significance to its location. Indeed, we can make this a feature in the reordered layout in the north porch or entrance lobby.
