**St Lawrence Church  
Lechlade-on-Thames  
Gloucestershire**

**A REPORT ON A GROUND PENETRATING RADAR SURVEY**

**St Lawrence Church PCC**

September 2018

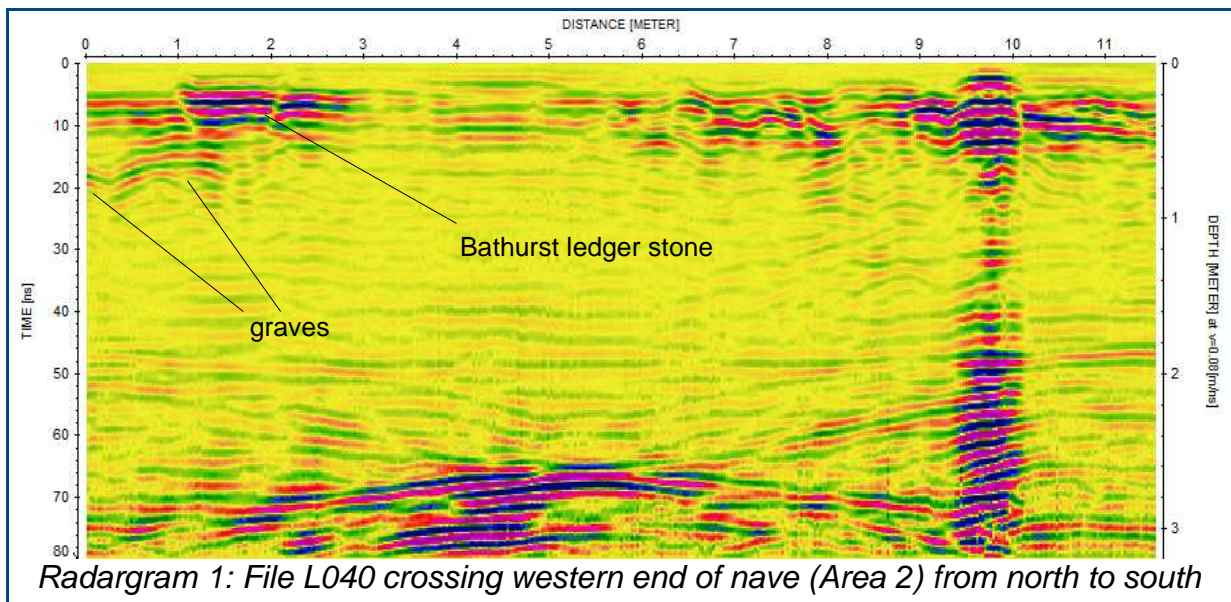
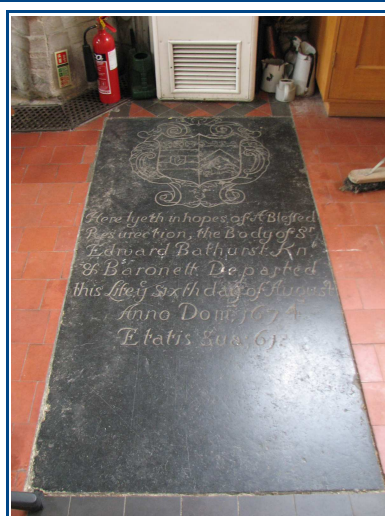
*Plate 2: Bathurst ledgerstone in north west part of nave*

(1) - Planar surface reflections within the north western part of the nave relate to a ledgerstone set into the floor that has an inscription to Edward Bathurst who died in 1674, see Radargram 1 and Plate 2. The stone appears to overlie possibly two hyperbolic reflectors that probably represent graves; however, they appear offset to the north and are only partly covered by the survey due to cupboards set against the northern and western interior walls of the nave. The offset may imply that the ledgerstone has been moved and reset into its current location and any relationship with the graves is uncertain. The top of the response to main hyperbolic reflector is approximately 0.4m below the surface and its morphology may indicate a small barrel vault.

(6) - The Bathurst ledgerstone is discussed above with anomaly (1). The stone may not be in its original position.

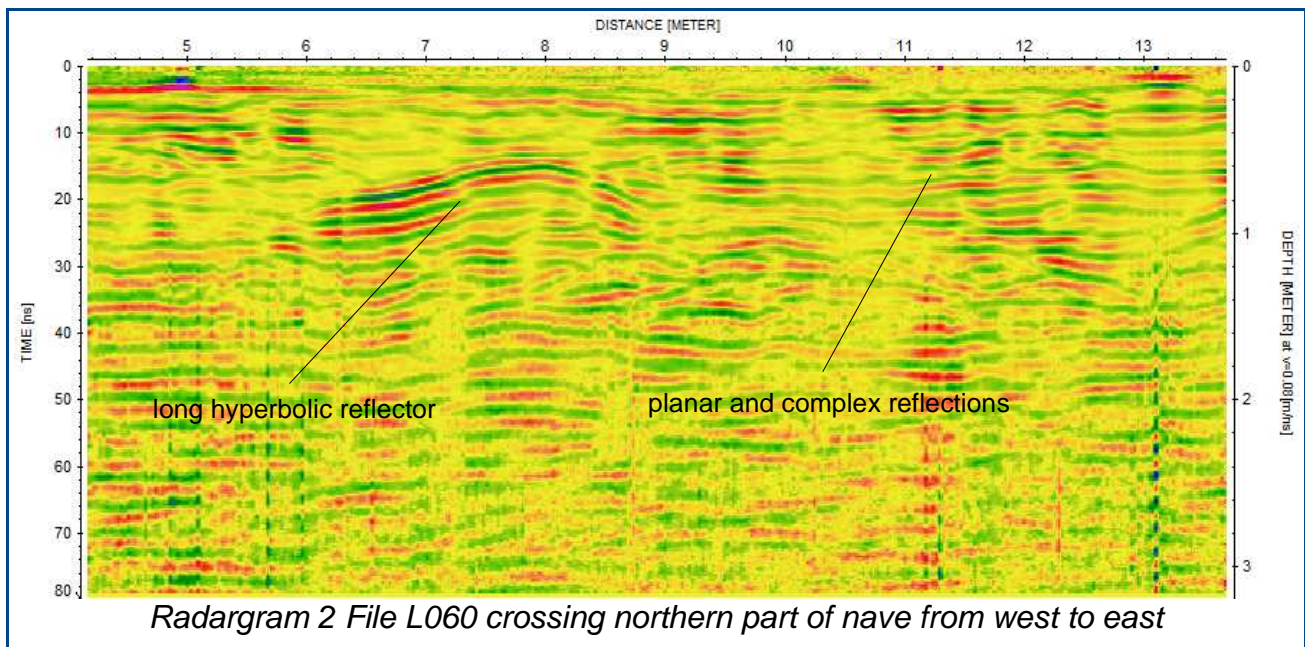
(2) - Planar, hyperbolic and complex reflections appear in two zones immediately to the south of the north wall of the nave to the east of the door to the north porch, see Radargram 2. It is likely that they represent vaults and graves. The western zone is characterised by a long hyperbolic reflector (approximately 3m long) that becomes more complex and fragmented from a distance of approximately 1m south of the nave wall. The eastern zone lacks hyperbola and is characterised by planar reflections representing horizontal layers just over 2m in length along the west to east extent. The upper part of hyperbolic reflector forming the western zone appears to be approximately 0.5m in depth with reflections extending to around 1.5m. Planar reflections forming the eastern zone appear at around 0.25m and may also extend to about 1.5m.

- 4.1.1 The interpretation and abstraction of the GPR data indicates the presence of several unmarked graves or vaults. Anomalies (2) and (4) represent zones within the northern and southern aisles respectively that appear to represent subsurface disturbance to approximately 1.5m, and it is considered likely that these represent a series of graves or vaults. The reflections associated with the two zones do not clearly resolve the structure of these features which in part may be a consequence of the west to east traversing, but may also indicate backfilling of voids with rubble and soil.

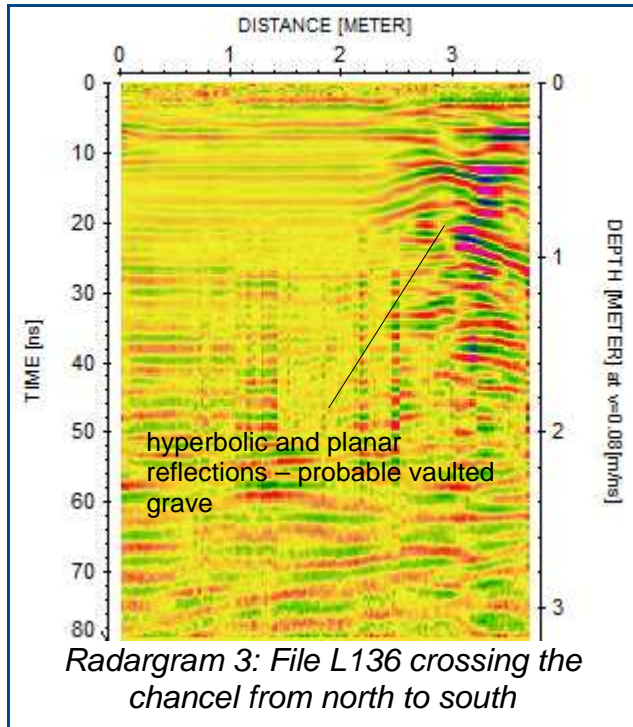
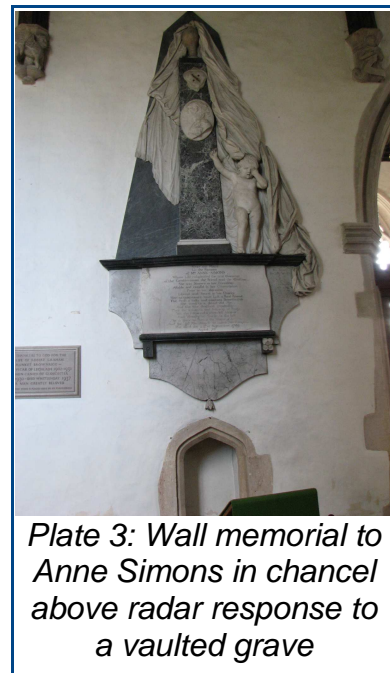
(3) - Planar and hyperbolic reflections close to the south wall of the chancel represent a vaulted grave, see Radargram 3. Due to the constraints to the survey area, it is likely that the full extent of the structure has not been covered. The initial response appears shallow at approximately 0.2m with reflections indicating a potential depth of approximately 1.8m. On the south chancel wall, immediately above the GPR anomalies, there is a memorial to Mrs Anne Simons (see Plate 3), and it is considered likely that the feature is her grave.

- 4.1.2 A vaulted grave located in the chancel probably relates to the nearby wall memorial to Mrs Anne Simons, and probable graves in the north western part of the nave, in the north aisle, lie to the north of a ledgerstone to Edward Bathurst. As the graves only partly underlie the ledgerstone, it is unclear as to whether it has been repositioned from elsewhere or reset a short distance away from its original location. Characteristic hyperbolic reflections from beneath the northern porch floor have tentatively been interpreted as a possible grave. Early ledgerstones with brasses in the north eastern and south eastern parts of the nave do not appear to be associated with grave-like reflections. Similarly, ledgerstones set into the tower floor cannot be confidently associated with evidence for graves.

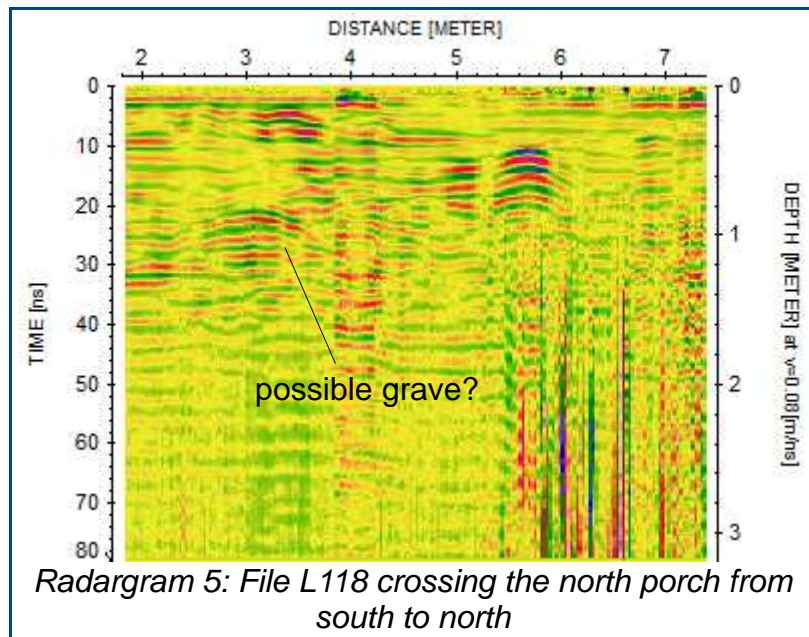
(5) - Several hyperbolic reflections were recorded within the northern porch, see Radargram 5. They are located at a depth of approximately 0.8m and suggest a feature orientated east - west with similar dimensions to a grave.

The interpretation is somewhat tentative due to the constraints of the survey area and its location within the north porch.

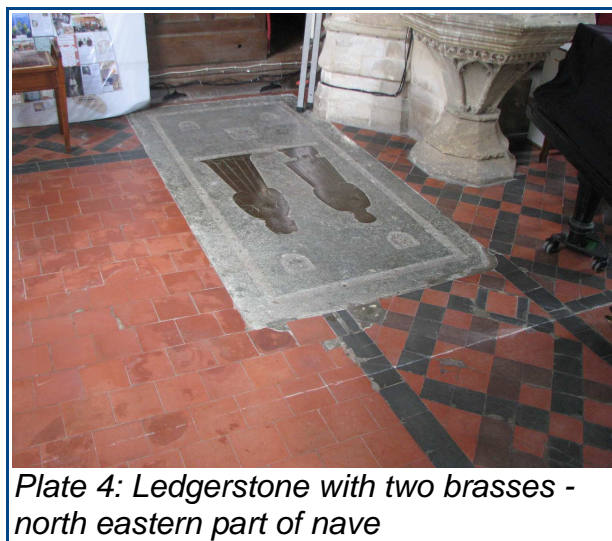
Plate 4: Ledgerstone with two brasses - north eastern part of nave

(7) - A large ledgerstone in the north eastern part of the nave, with two brasses, to John Townsend, Ellen, his wife and six children c1458 (Plate 4). The survey has recorded multiple planar reflections from the stone with very strong reflections from the brass. There is no convincing evidence for a grave beneath the stone.

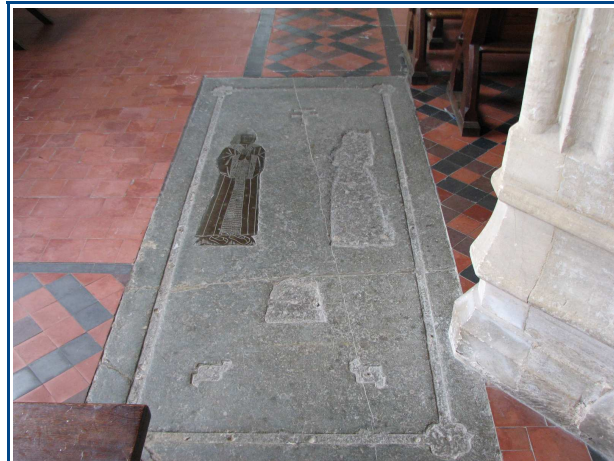
Plate 5: Ledgerstone with one brass - south eastern part of nave

(8) - A large ledgerstone, with two brasses, in the south eastern part of the nave to Robert Hitchman and wife c1510 (Plate 5). The survey has recorded multiple planar reflections from the stone with very strong reflections from the brass. There is no convincing evidence for a grave beneath the stone.

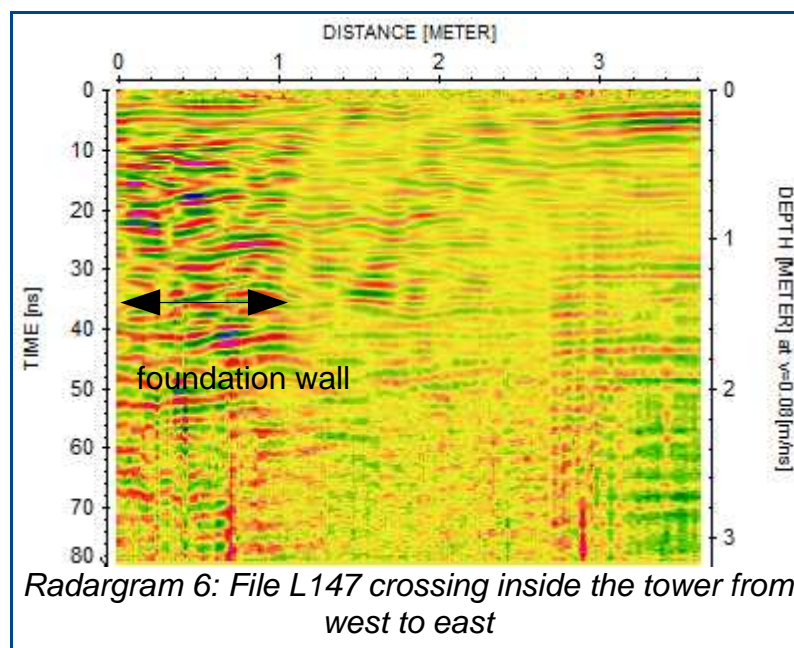
Radargram 6: File L147 crossing inside the tower from west to east

(9) - A zone of complex reflections within the western side of the tower, see Radargram 6. The anomalies occur at approximately 0.1m to 2m in depth. They appear to be confined to a rectangular area that lies within the western entrance to the tower, their eastern limit appears to extend no further than the internal eastern side of the tower wall as indicated on the plan. It is considered likely that during the construction of the tower a substantial foundation wall was built up to just below the floor level and threshold of the western entrance.

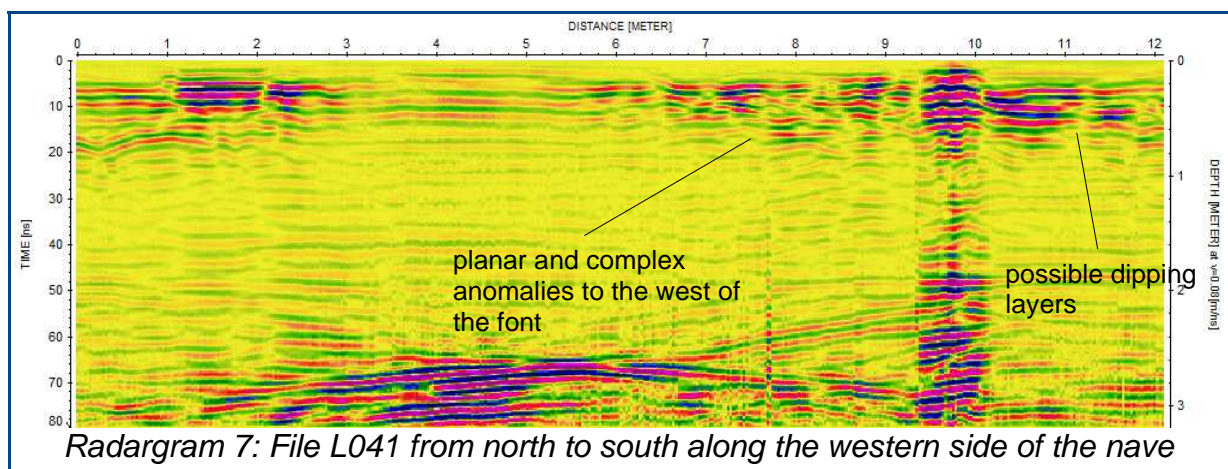
(15) - Planar, hyperbolic and complex reflections below the floor appear to infer a subsurface layer dipping slightly to the south. The anomalies may indicate disturbance down to approximately 1m, see Radargram 7.
