## **Church of St Lawrence, Lechlade-on-Thames, Gloucestershire**

**An Archaeological Watching Brief Report**

**For Nigel Jones on behalf of  
Lechlade PCC**

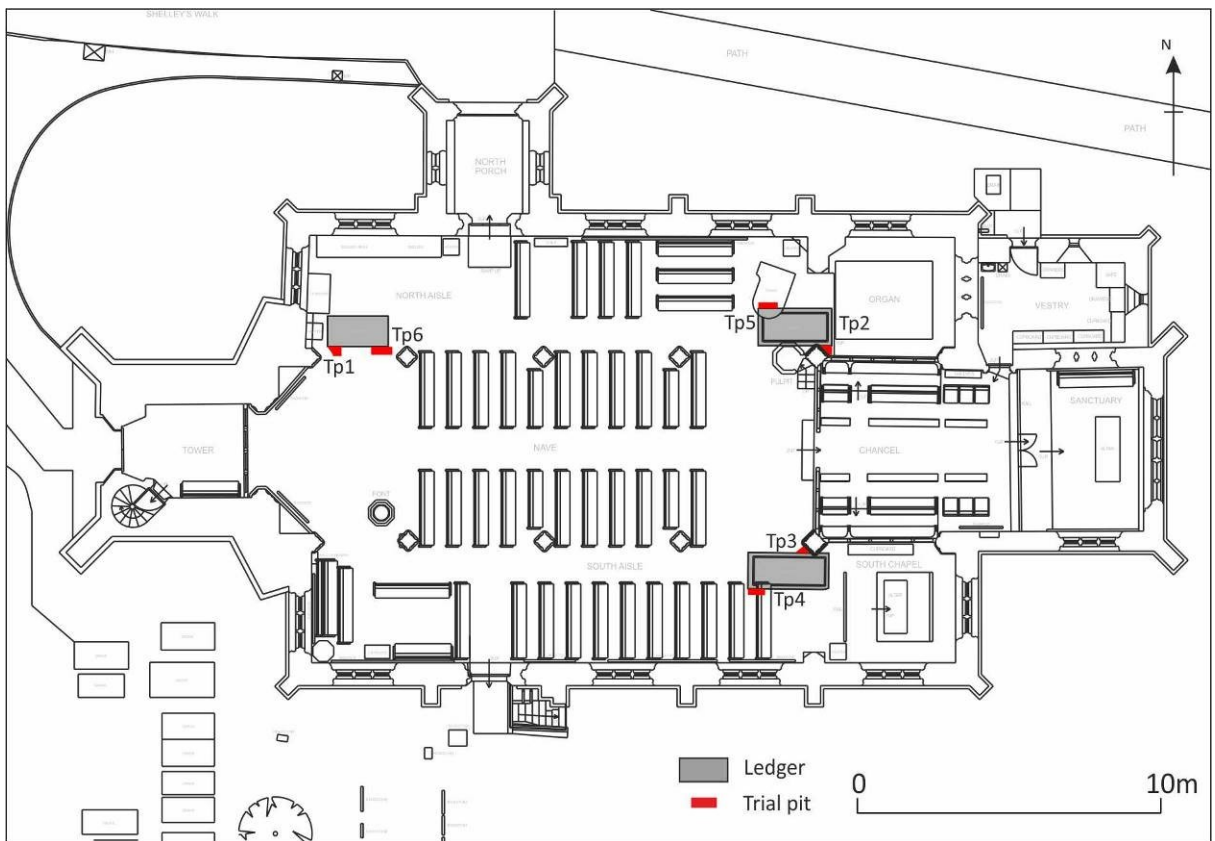
Fig. 2 Location of test pits

- 1.1 On 25th February 2020 Urban Archaeology carried out an archaeological watching brief for Nigel Jones, on behalf of Lechlade PCC, at the church of St Lawrence, Lechlade-on-Thames, Gloucestershire, GL7 3AB, SU 21494 99503 (Fig. 1). As part of planning for a potential reordering of the church six trial pits were excavated adjacent to the three ledger stones which are set into the floor of the church, in order to establish their relationship to the Victorian limecrete screed which is known to lie across the church interior (Fig. 2).
