St Lawrence Church

LECHLADE-ON-THAMES

Chiz Harward BA MCifA
Urban Archaeology

March 2023

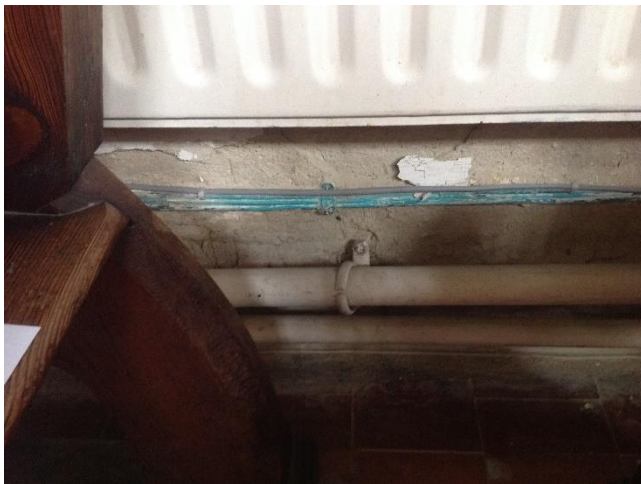
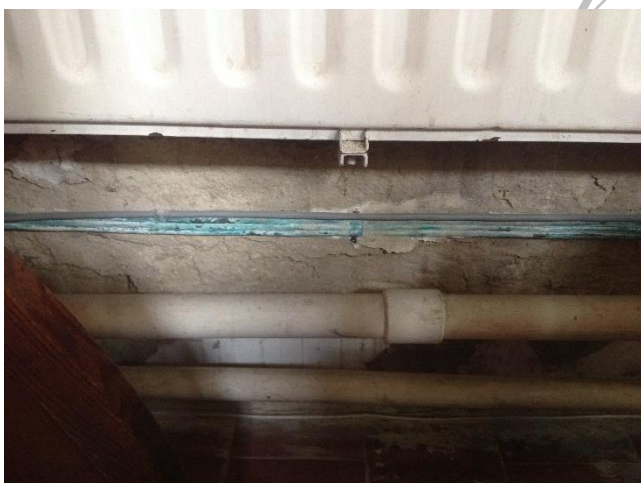
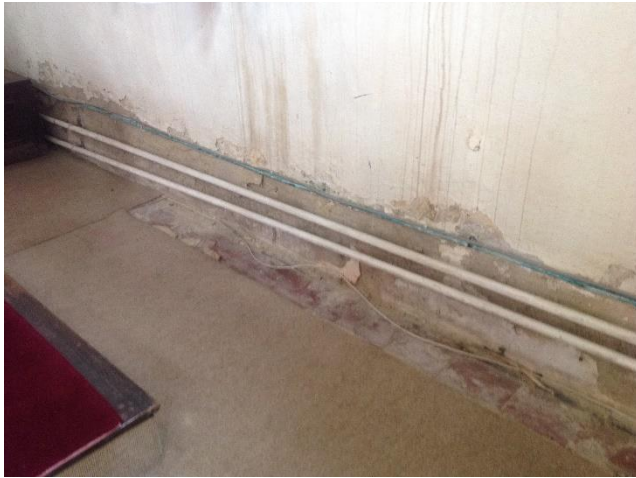
Photographs C1a to c: South internal wall showing the loss of lime plaster due to the effect of copper sheathed MIC cabling. The proposals are to rewire and renew the heating system with all cabling and pipes below floor level. This will enable restoration of the lime plaster and redecoration.

- The south doorway will be unsealed, and the original wooden door restored.
- Lighting and heating will be replaced. An air source heat pump and underfloor heating is proposed. The existing radiators and pipes will be removed from the walls and services buried within the new floor.

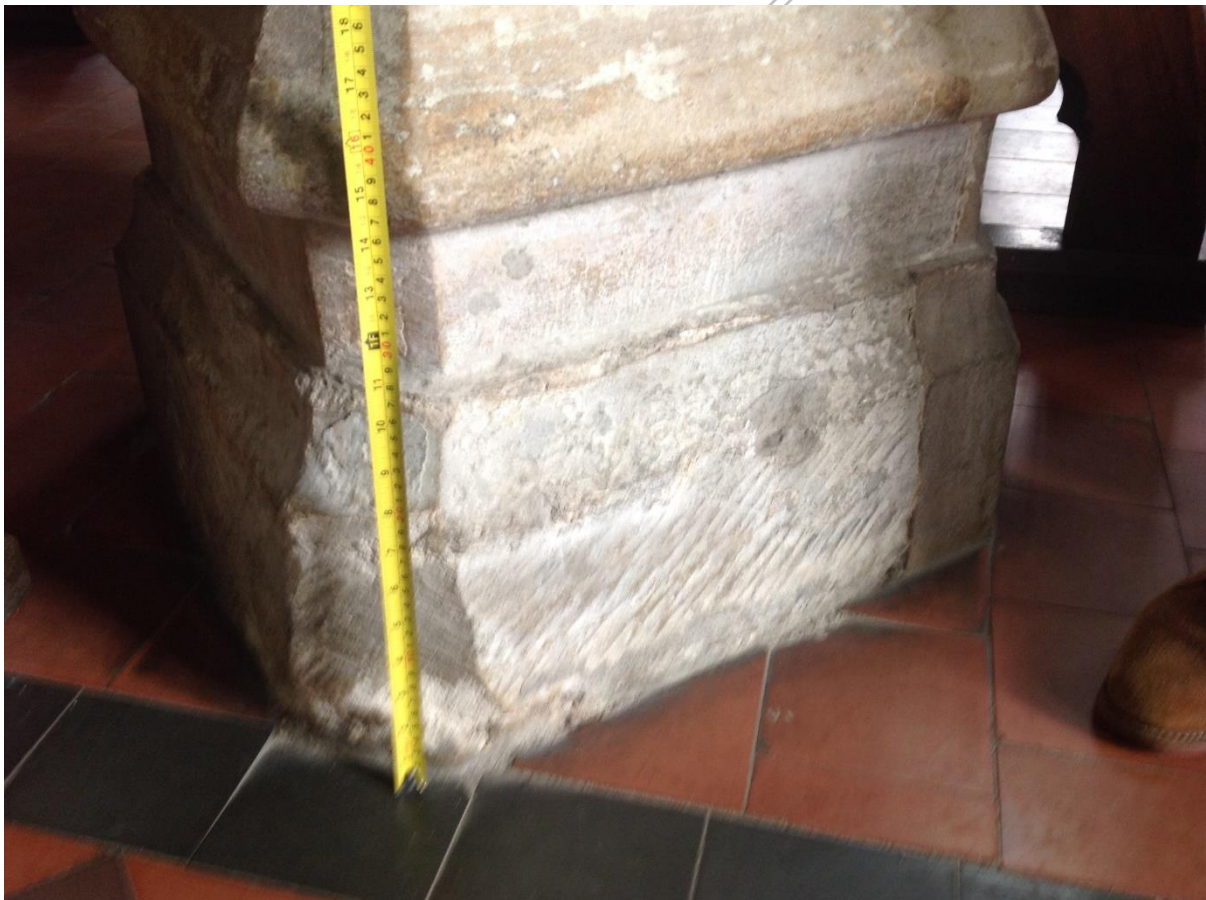
Photograph C2: Base of internal columns showing undressed stone indicating a higher floor level pre 1882 suggesting the original stone floor was at a higher level before the 1882 re-ordering.

Given that the floor was reduced by at least 150mm in 1882 to accommodate the new limecrete screed, it is presumed that most of the earlier floor levels and sub floors will have been removed at this point, whether the original floor levels were retained or not. Recent coring of the floor confirmed the lime concrete floor was hard to drill through and is 125mm to 150mm thick. Compacted earth was found below this and easy to penetrate.

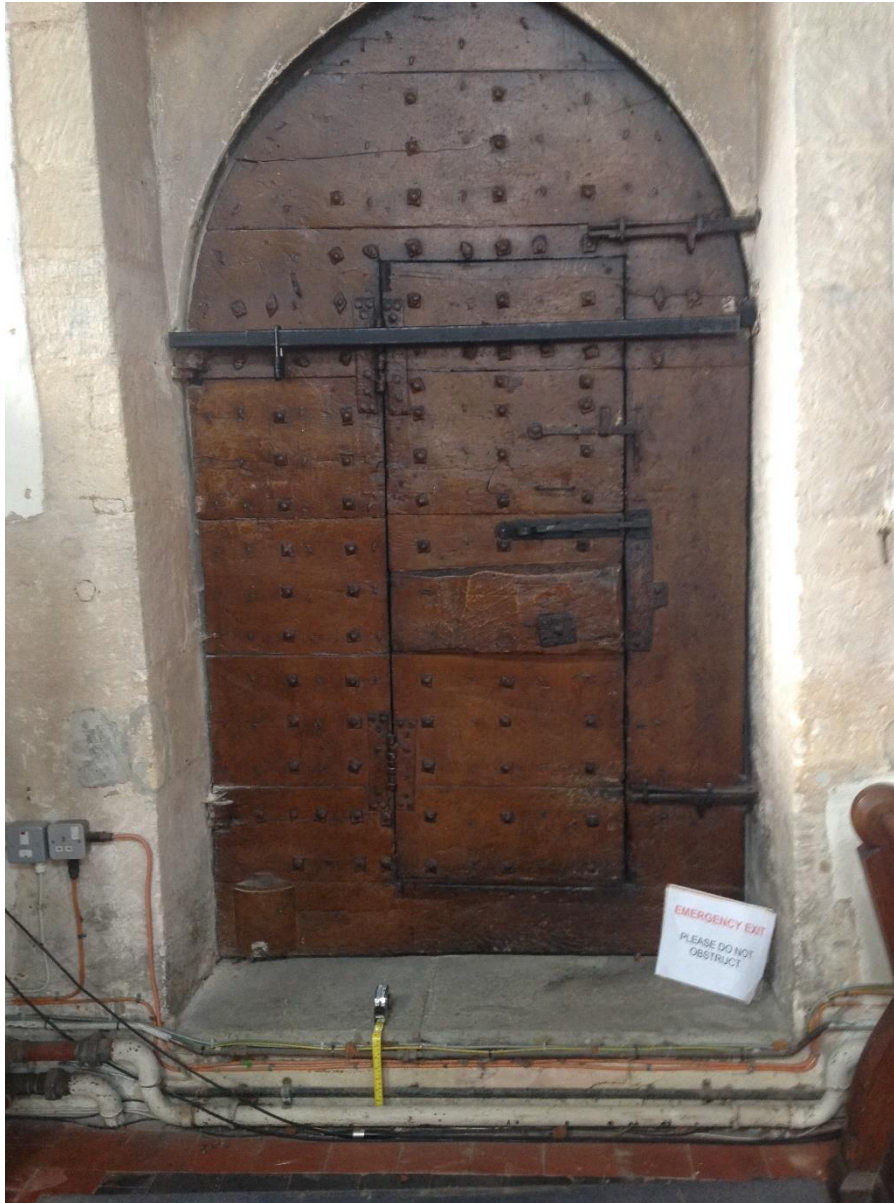
Photograph C3: North porch door from inside the church. Note the sill level is some 200mm above current floor level. A temporary timber ramp is provided with a gradient of 1 in 5. The proposal is to raise the floor to provide level access from the north porch to the altar rail.

A key objective is to allow for level access from the restored north porch to the communion rail. This will also allow the south door to be used without steps. The option to have a slope from the nave to the chancel was considered but found not to be feasible and would cause a greater impact. By raising the floor and protecting the tiles beneath, the impact is minimised for maximum benefit.

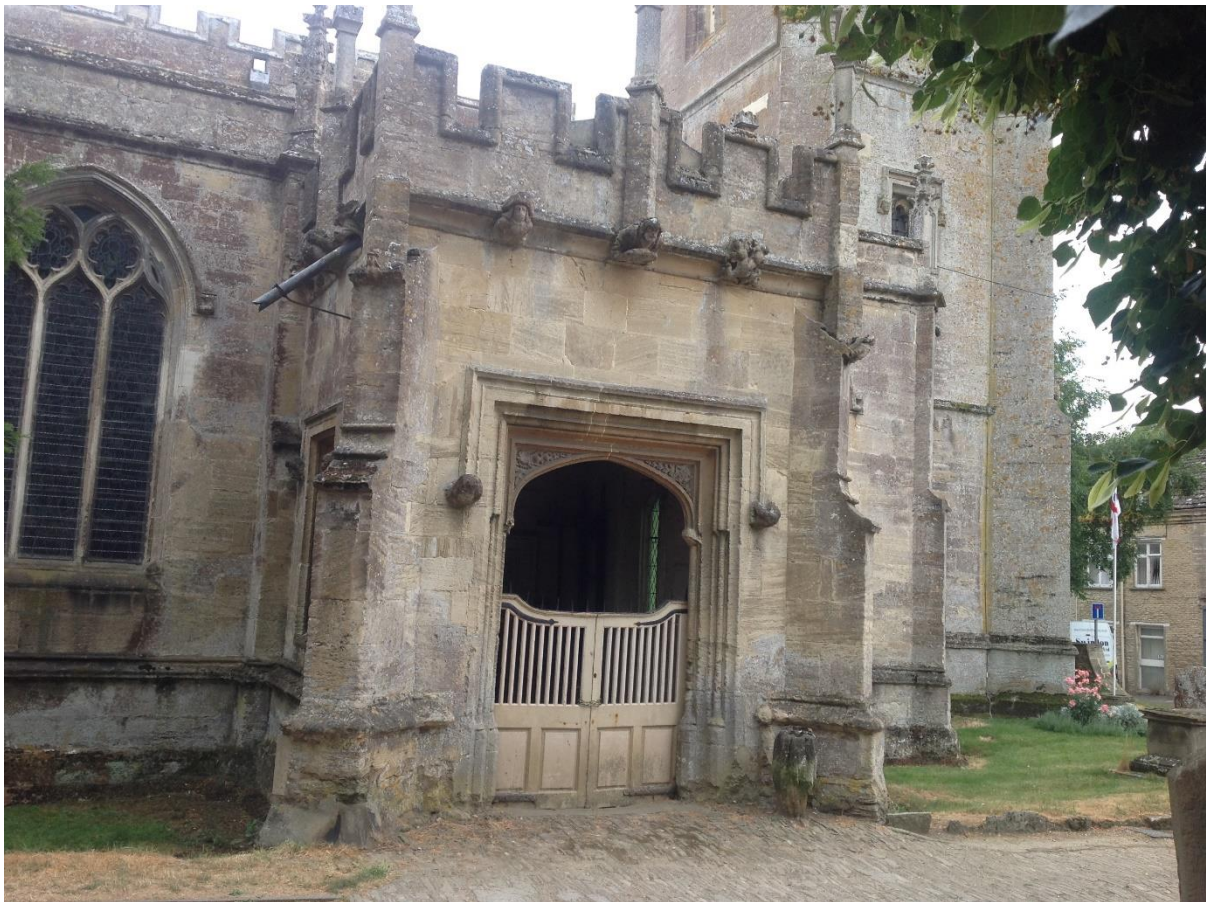
Photograph C4: External view of the north porch showing the timber palisade entrance gate. The porch is open to the elements. The proposal is to enclose the porch with external doors to protect the internal structure and finishes, make best use of the space. The access through the porch will allow people to appreciate this important structure, particularly the ceiling. Note the uneven stone cobbled area and footpath outside the porch.

The existing wooden palisade gates will be removed and replaced with a traditional solid timber boarded door which will be fixed open when the church is in use. The doors are not likely to impact on views of the porch from the east and west.

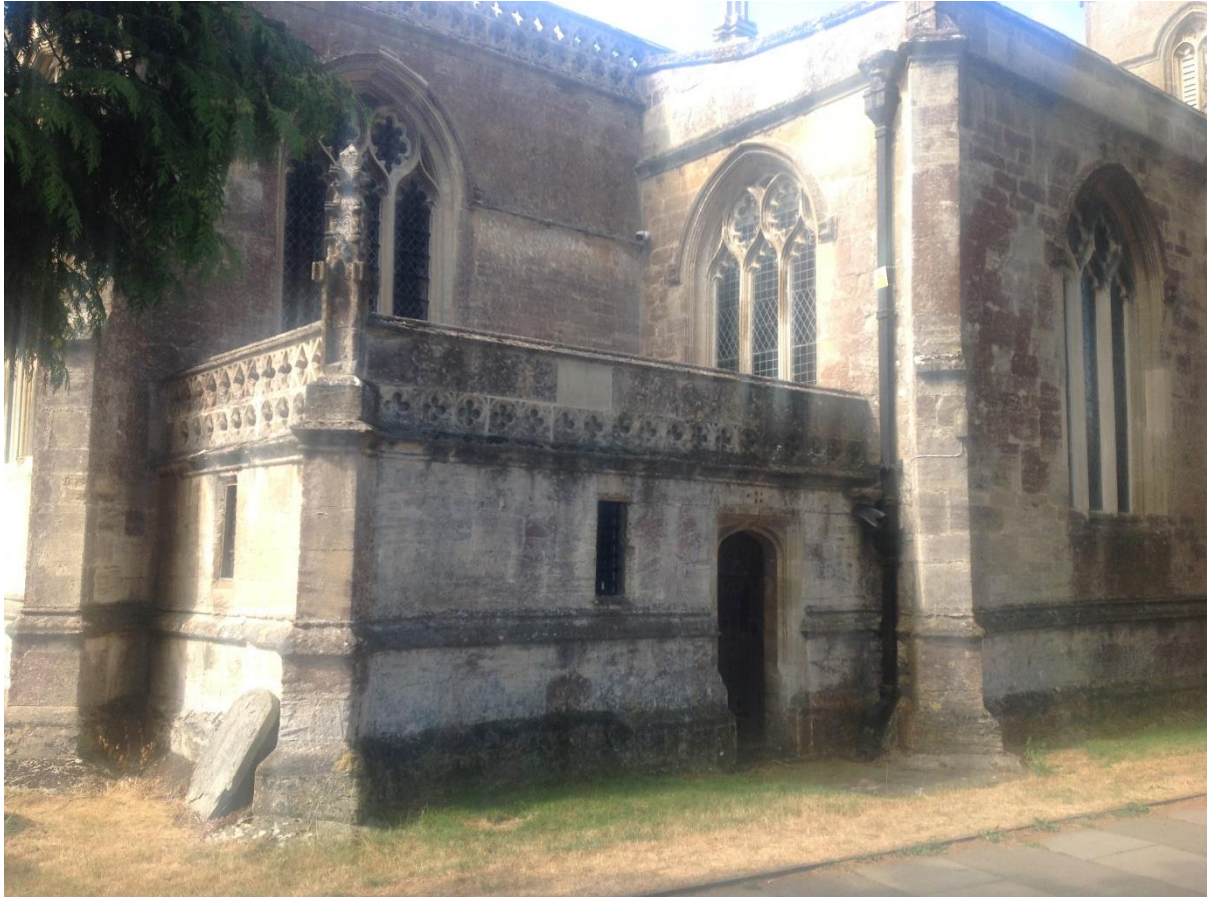
Photograph C6: The vestry is located on the northeast corner of the church. The date of construction is unclear although we do know that the external door was added and ground lowered at the time of the 1881 reordering.
